130 Liberty Street
New York, New York

Supplemental Investigation
Summary Report

Visual Mold Inspection Summary

February 22, 2005

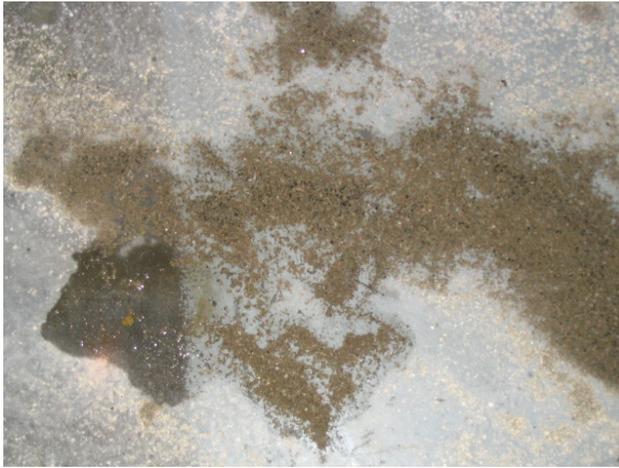
Figure 1: Floor 41 mold on flooring near pipe leak.

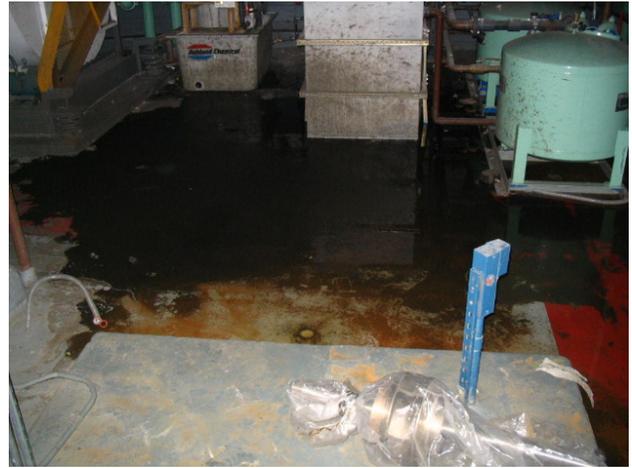
Figure 2 : Floor 40 water damage and mold.

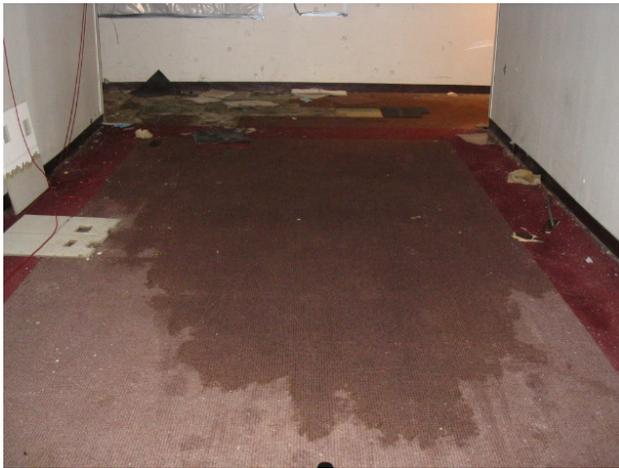
Figure 3: Floor 39 water damage

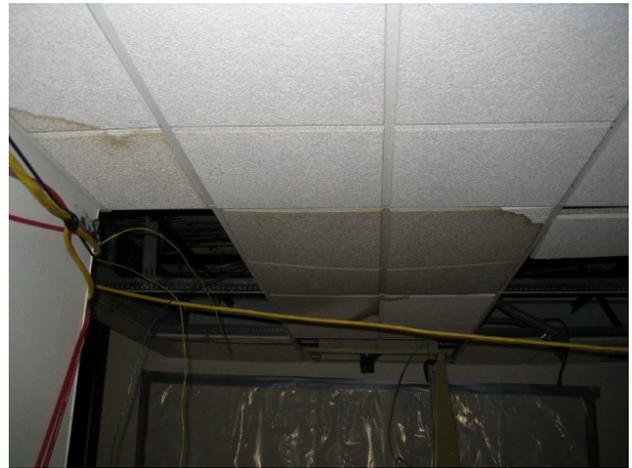
Figure 4: Floor 39 water damage.

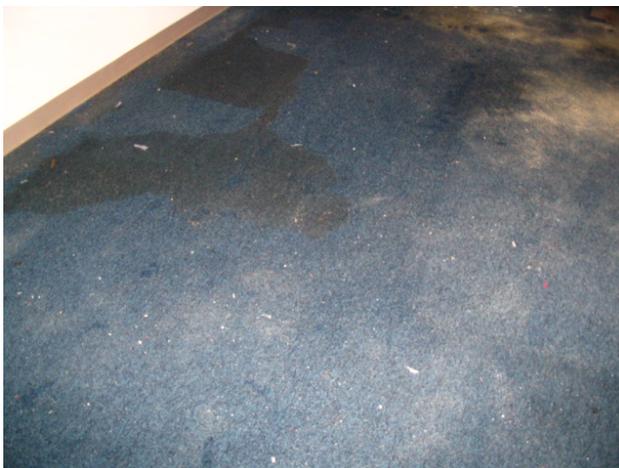
Figure 5: Floor 27 carpet water damage

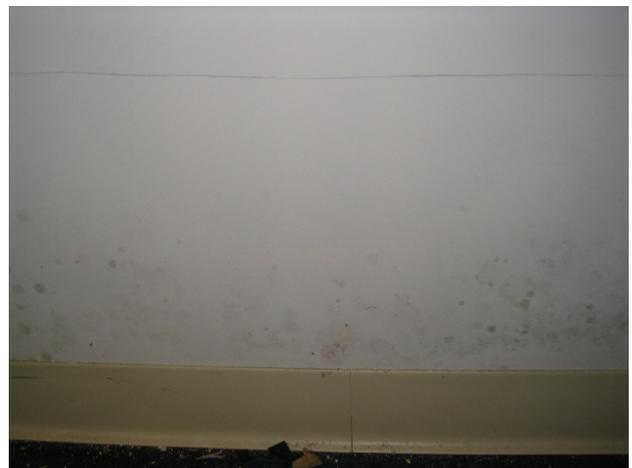
Figure 6: Floor 32 sheetrock mold

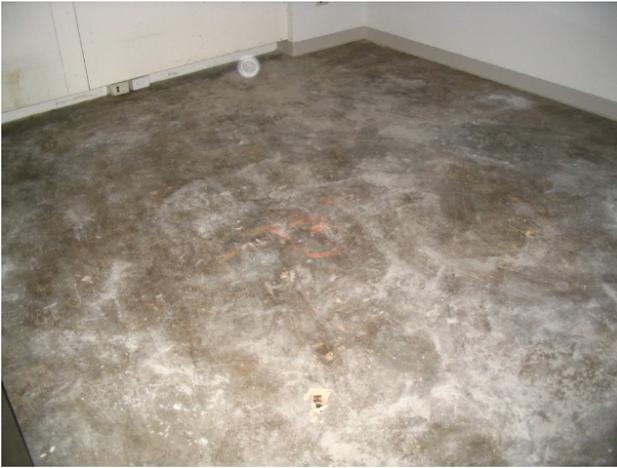
Figure 7: Floor 27 carpet water damage and visible mold

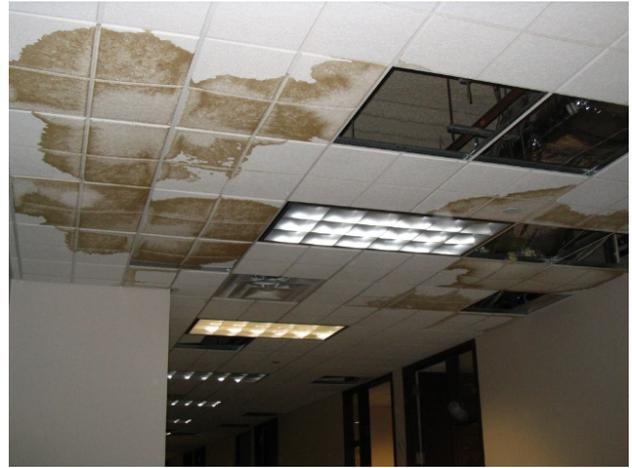
Figure 8: Floor 32 water damage

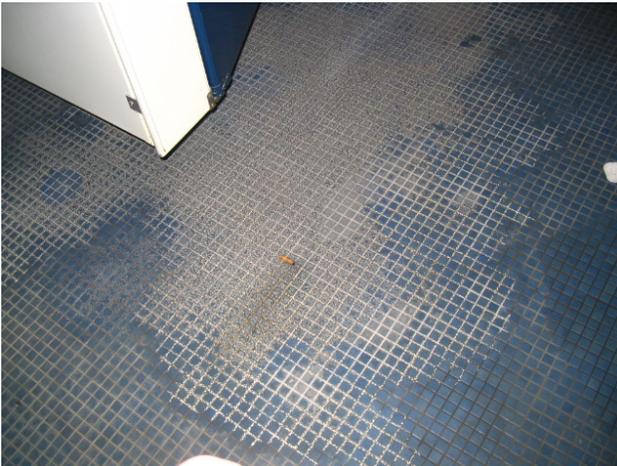
Figure 9: Floor 28 mold on flooring

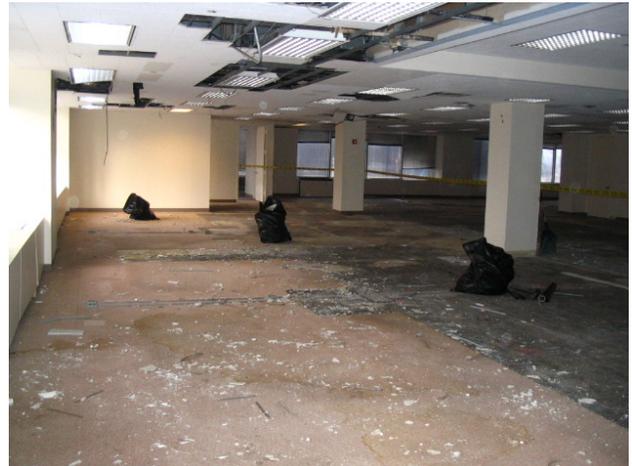
Figure 10: Floor 23 water damage

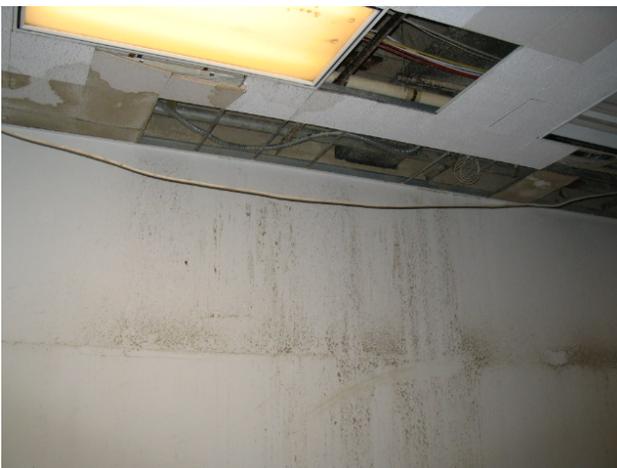
Figure 11: Floor 22 water damage

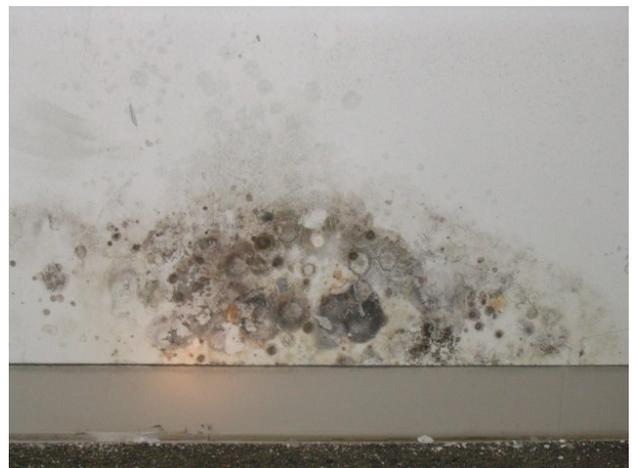
Figure 12: Floor 11 visible mold on sheetrock

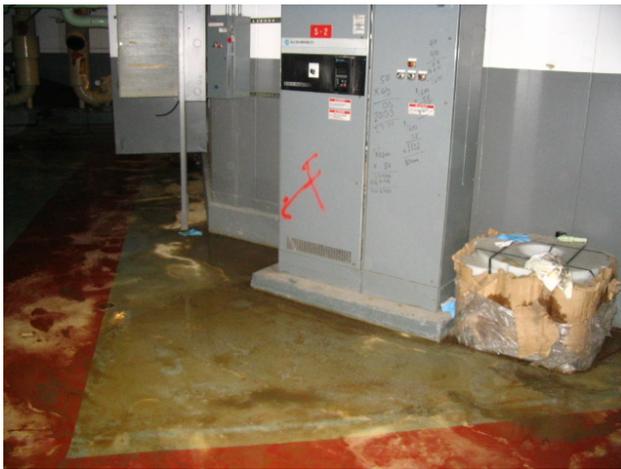
Figure 13: 5th Floor water damage

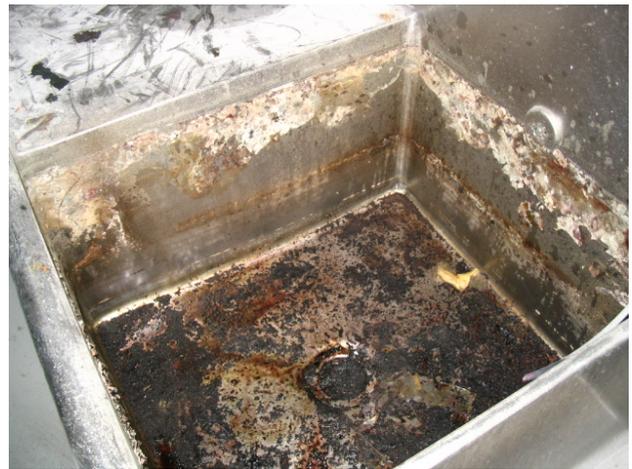
Figure 14: 4th Floor mold in sink

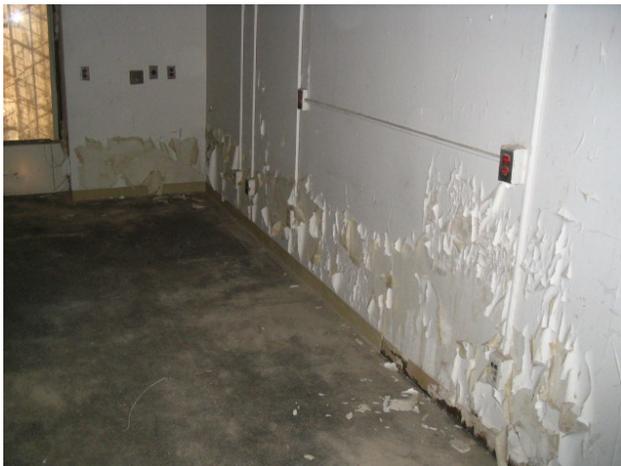
Figure 15: Floor 1 water damage

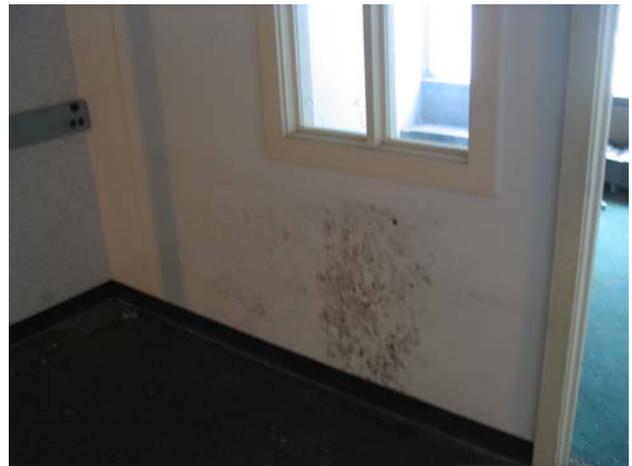
Figure 16: Floor 1 mold on sheetrock

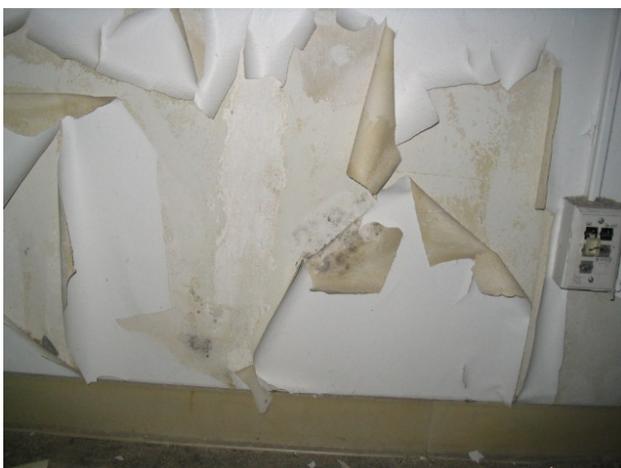
Figure 17: Floor 1 water damage
