Final Technical Report

**World Trade Center Memorial and Development Plan:
Data Recovery and Analysis of the WTC Ship**

**Blocks 54, Lot 1 and Block 56, Lots 15, 20, and 21
New York, New York**

August 2013

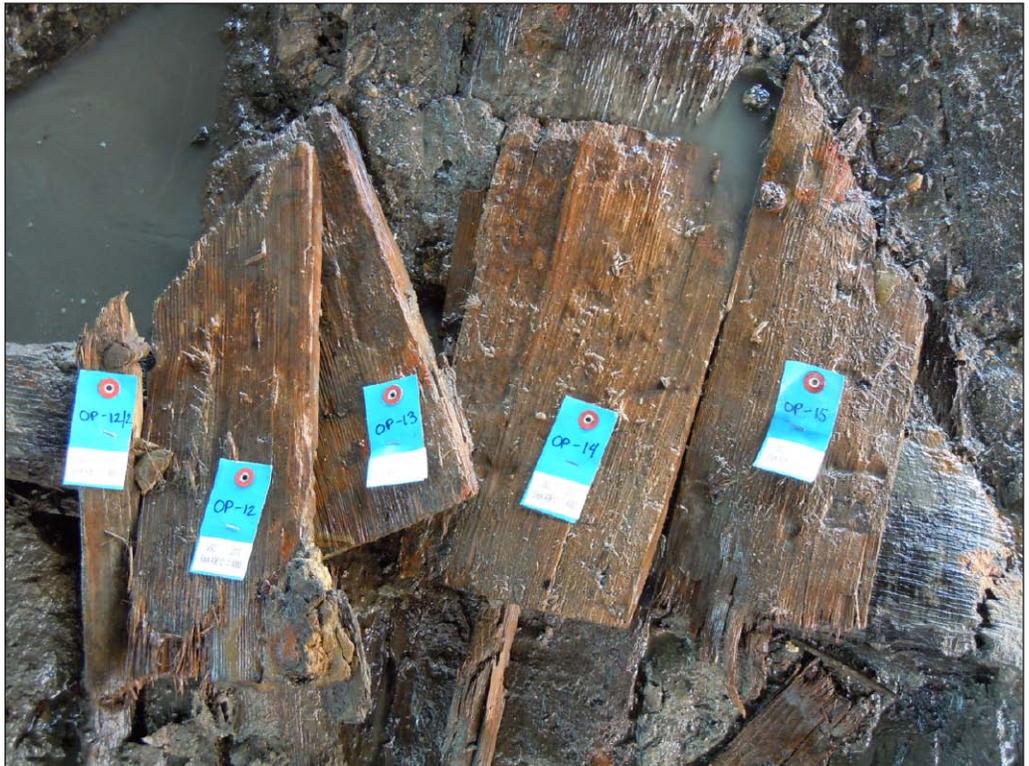
B

Example of labeling and photographic documentation of timber elements on the orlop deck

After an identifier was created for each timber, Tyvek tags measuring approximately 2 inches by 4 inches were stapled to each timber using rust-proof Monel roofing staples (see **Figure 2-1B**). Blue tags were used for the stern and red tags for the bow. The Tyvek material was chosen for labeling due to its durability and water resistance and blue and red tags were chosen because they were more suitable for photographic documentation. The tags used for the timbers of the stern were pre-printed with the unique site number assigned to the WTC Ship by SHPO prior to documentation and removal activities. The site name and date was written on each tag used to label the timbers of the bow. As unique identification codes were assigned to each timber while in the field, that number was written on each tag using a permanent marker.

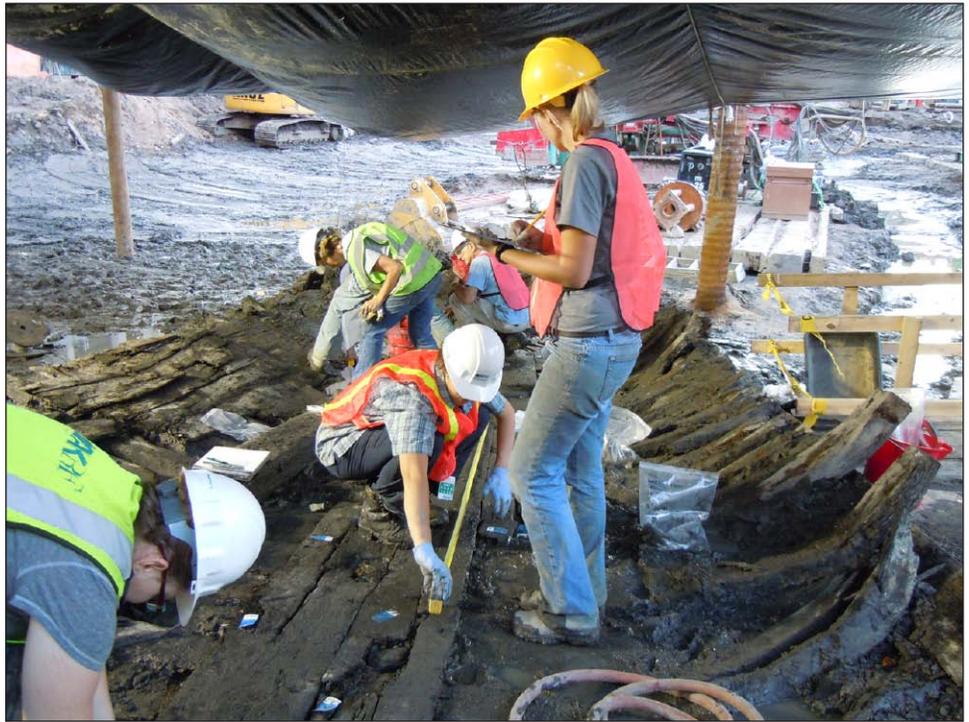
Facing east showing the recording of individual elements of the stern using standard field forms **A**

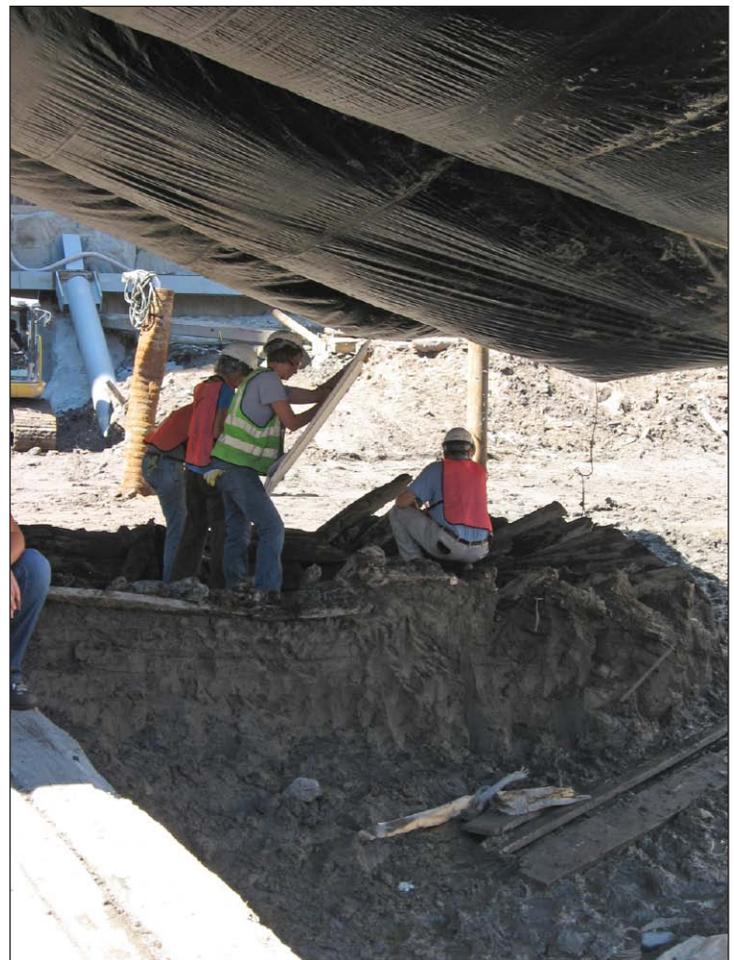
Facing south towards the west end of the ship under the protective awning showing the mapping of timber elements of the stern on large-format plans **B**

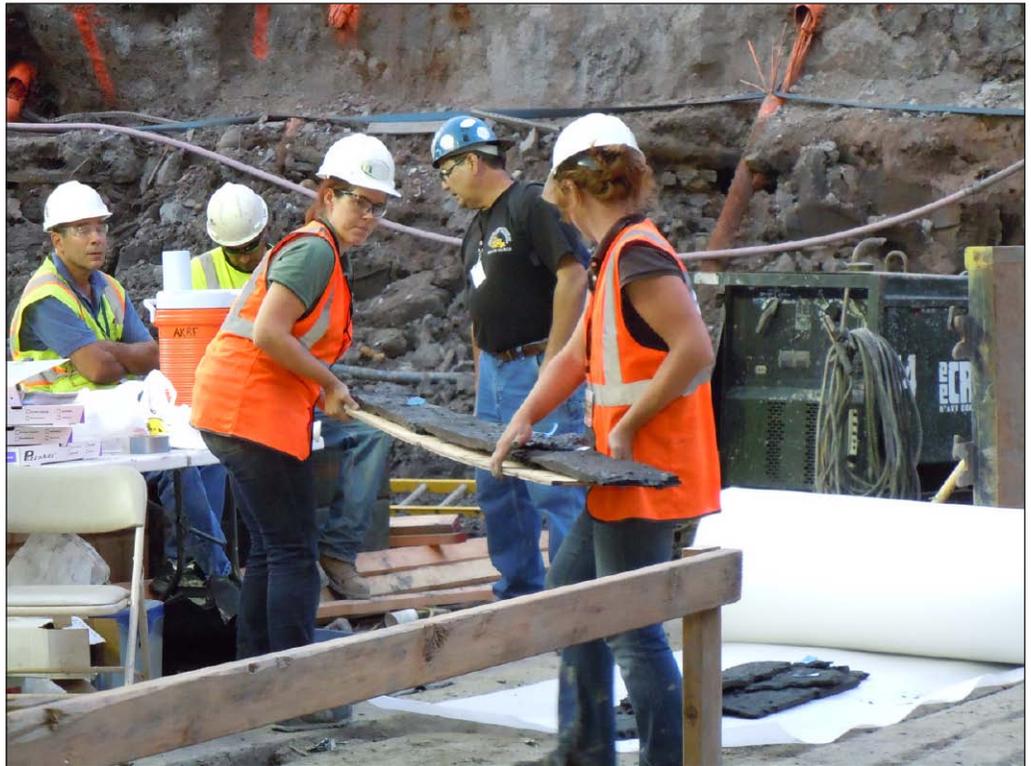
Conservators move fragile pieces on a plywood splint **A**

Following the documentation phase of each layer of the stern, archaeologists removed each timber element and transferred it to the on-site conservators for processing and packing. Each timber element was carefully pried loose using cedar or pine wedges and rubber mallets. Depending on the size and fragility of the timber, multiple archaeologists or laborers worked together to loosen and lift each element, trying to minimize damage either to the timber or to adjacent portions of the ship remnant. Long or fragile timbers were transferred directly onto plywood splints. Members of the field team or EE Cruz crew carried each timber from the ship to the conservators (see **Figure 2-3A**).

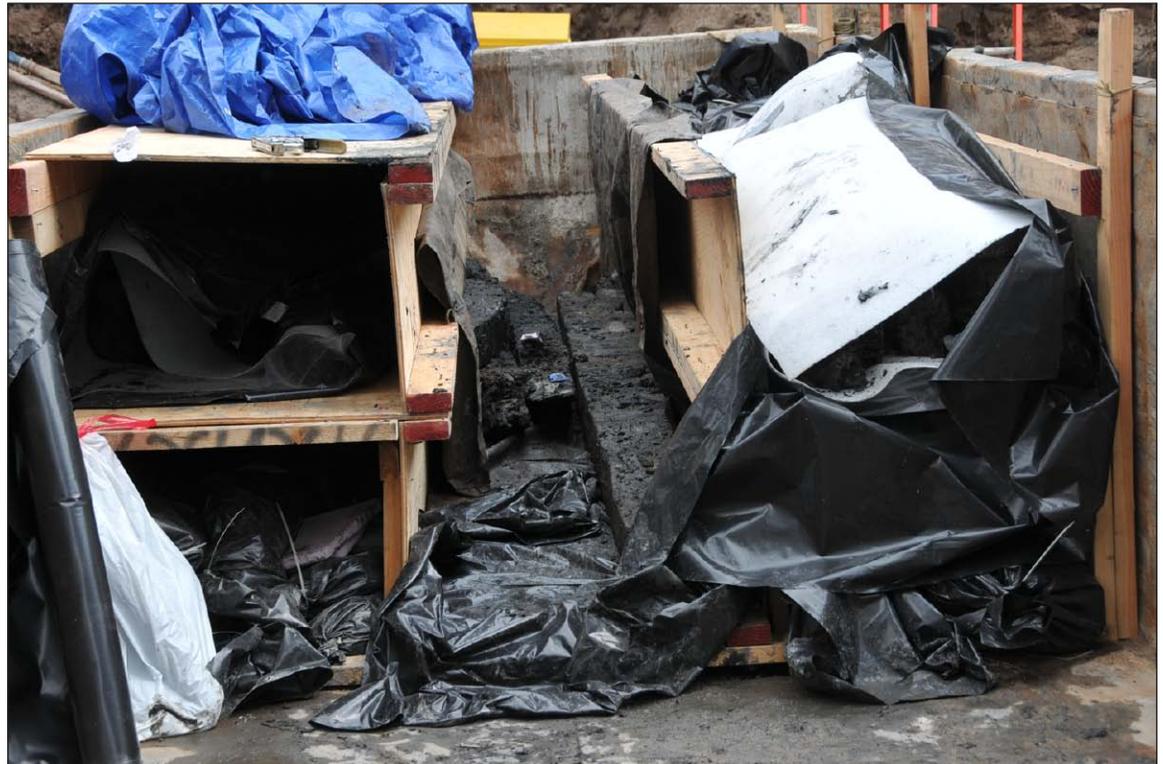
Stern timbers wrapped in foam and plastic sheeting are loaded onto wooden shelves in a shipping container **B**

After removal, each element was wrapped with polyethylene foam and plastic sheeting sealed with duct tape and/or plastic ties to protect the timbers and to retain moisture. The exterior of the wrapped timber was then labeled with the timber's unique identification code. Each timber was then positioned within one of two 10-yard storage containers that had been outfitted with wood shelving constructed specifically to protect the timbers (see **Figure 2-3B**). In limited instances, when timbers (such as the keelson) were too long to fit within the storage container, the on-site conservation crew directed the breakage of the timbers in a controlled manner. This was achieved by the manual or machine-assisted snapping of the timbers in such a way that they could be reassembled in the future with a minimally visible seam. When all of the vessel timbers had been removed, the storage containers were lifted out of the excavation site with a crane and trucked to the MAC Lab in Saint Leonard, Maryland, for immediate processing.

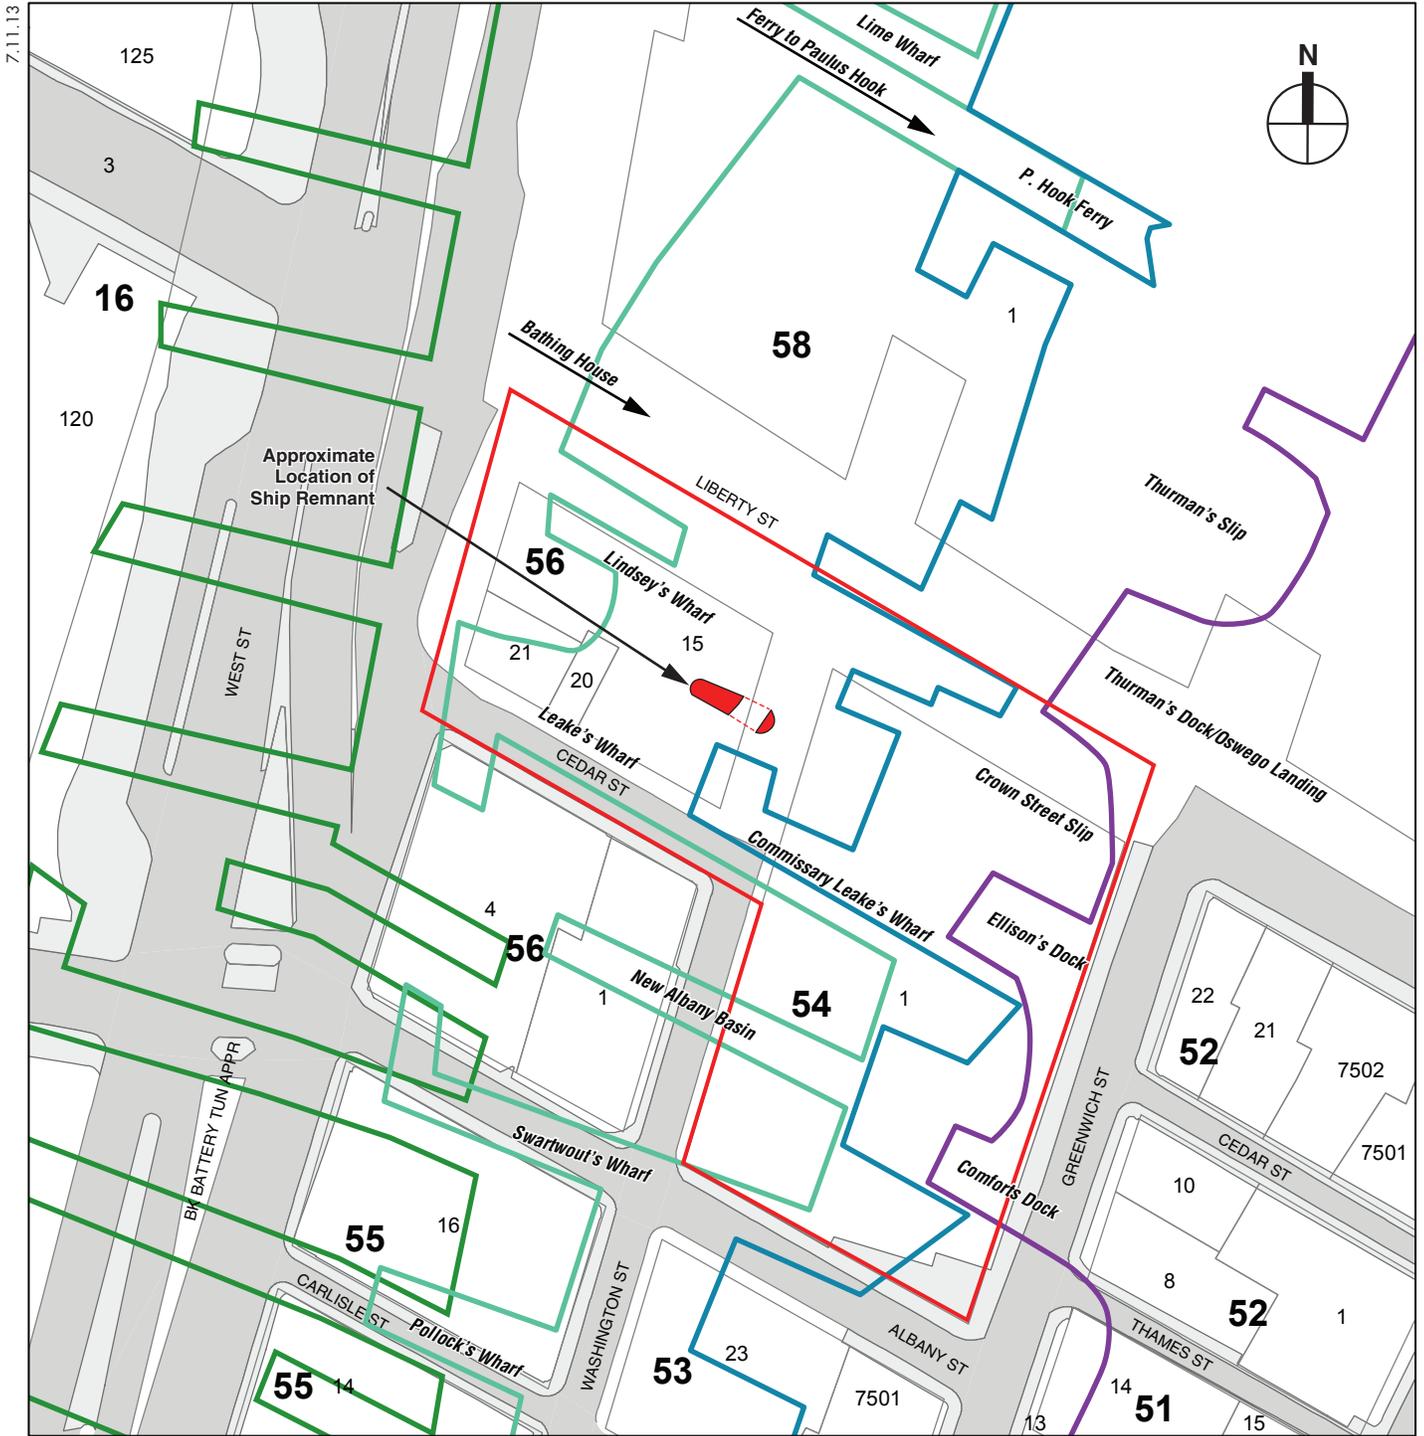
- VSC Site
- Shoreline in 1836 (Based on the 1836 Colton Map)
- Shoreline in 1797 (Based on the 1797 Taylor-Roberts Map)
- Shoreline in 1766 (Based on the 1776 Ratzer Map)
- Shoreline in 1730 (Based on the 1730 Lyne Map)

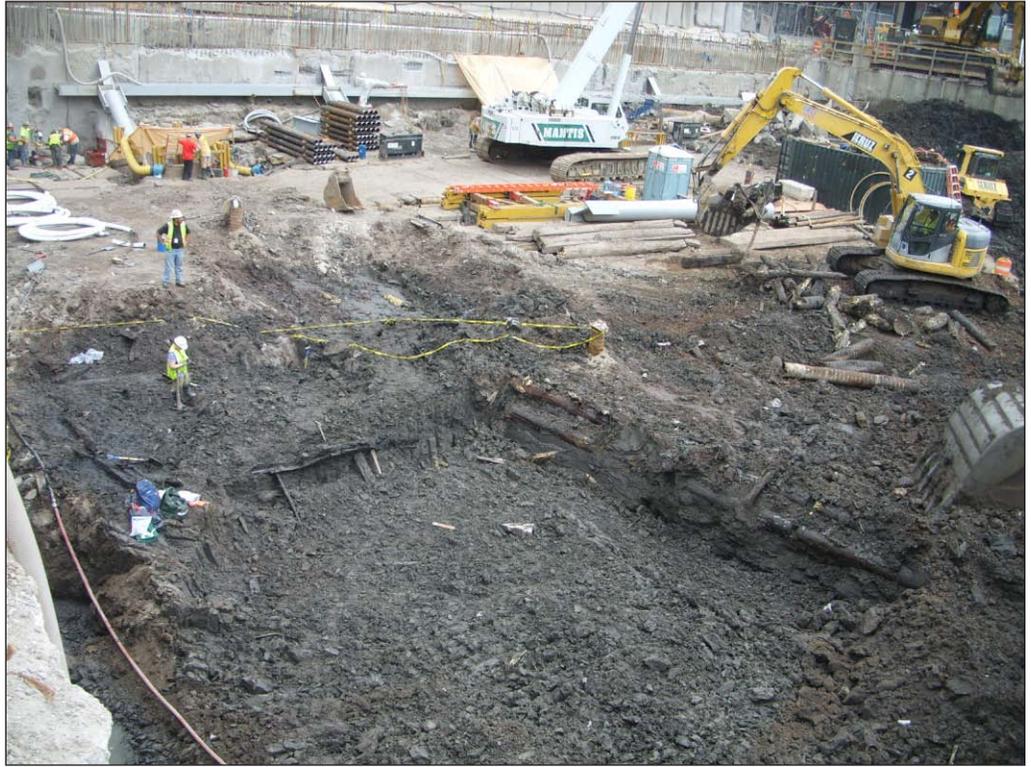
Aerial view of the ship remnant and associated landfill after the excavation of the sides of the vessel. **A**

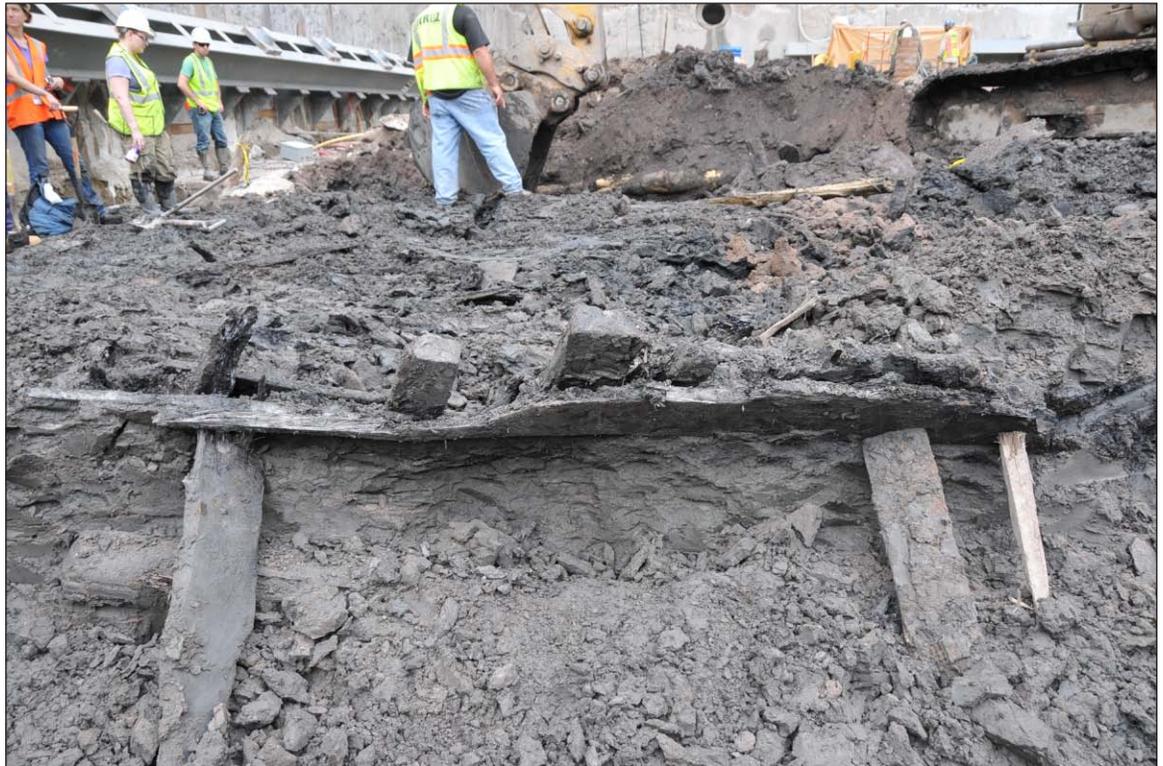
Close-up view of the northern (port) side of the stern after initial clearing and installation of temporary support beams. **B**

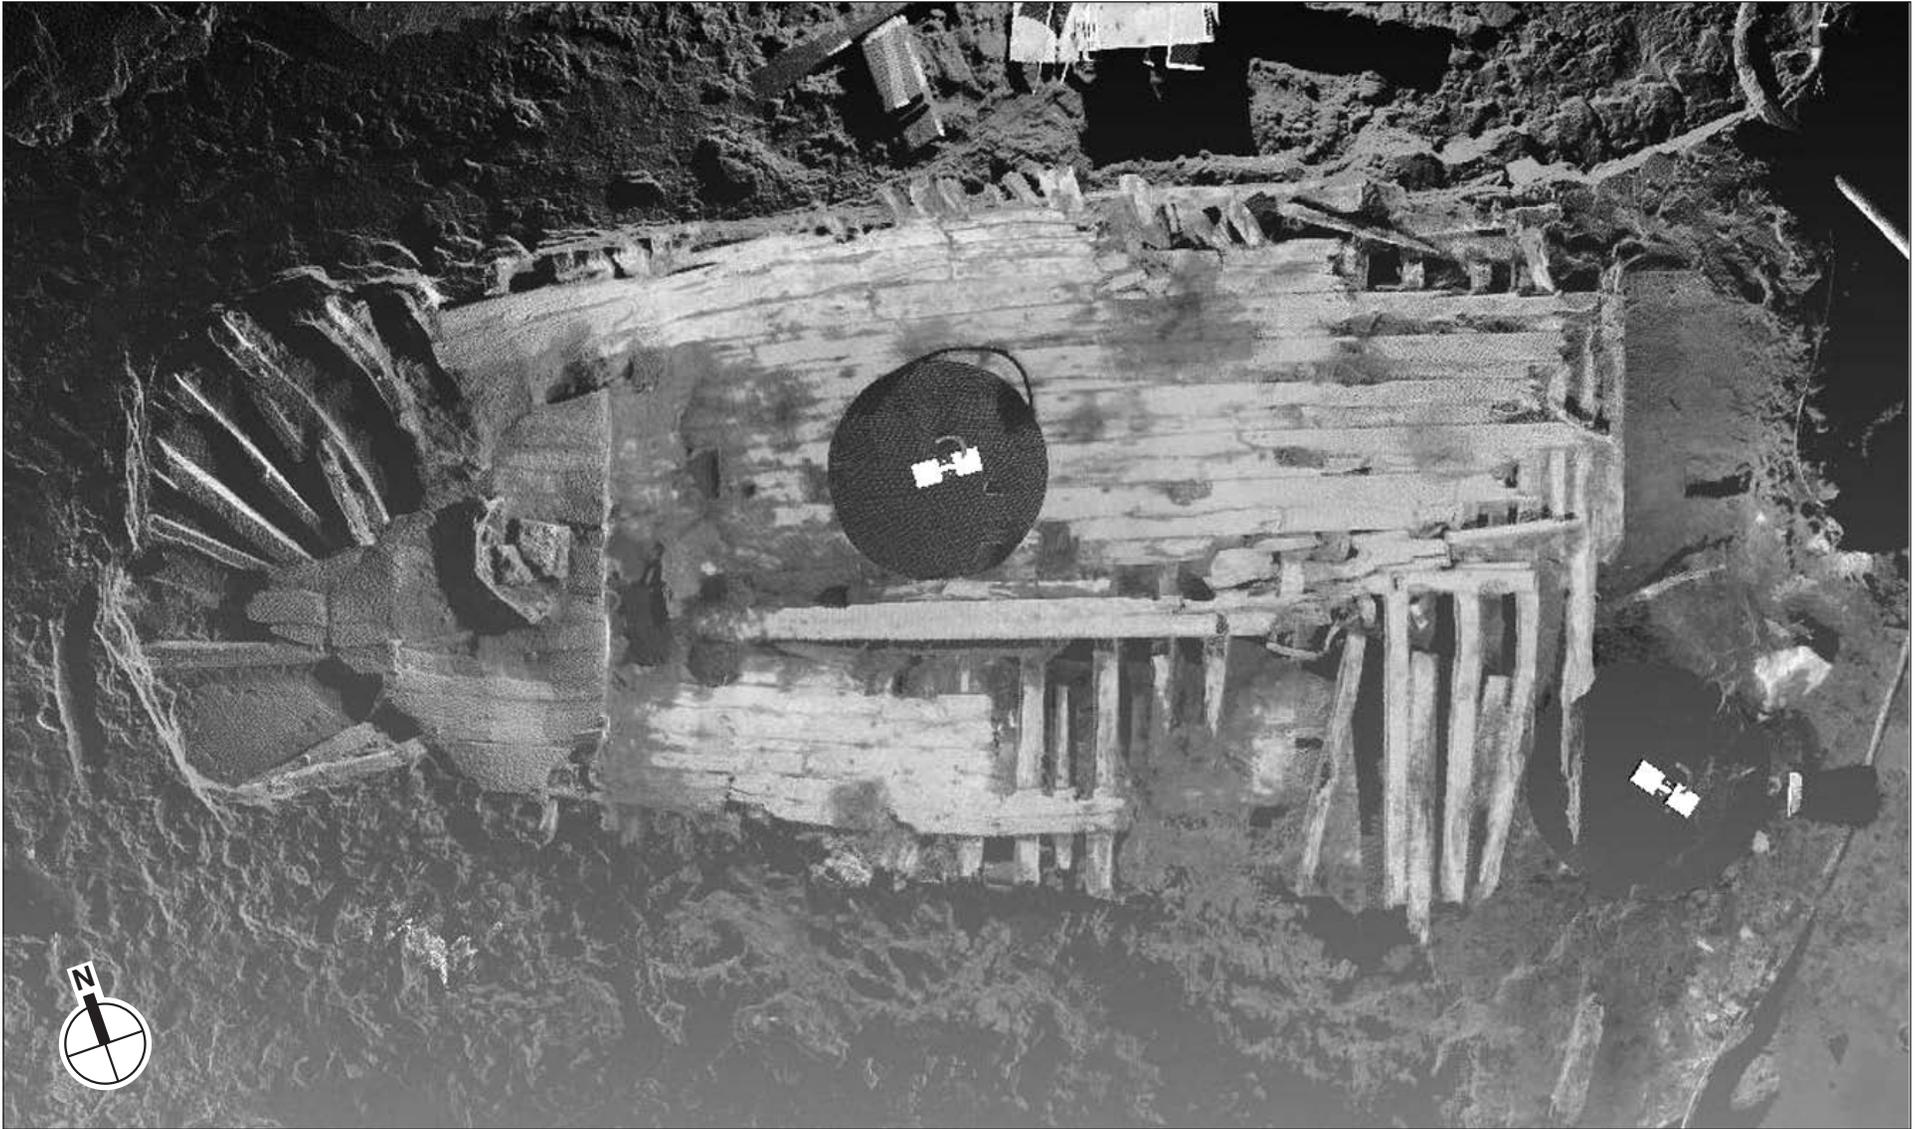
Laser Scan of Ceiling Planks and Orlop Deck (at Left)
Figure 5-3a

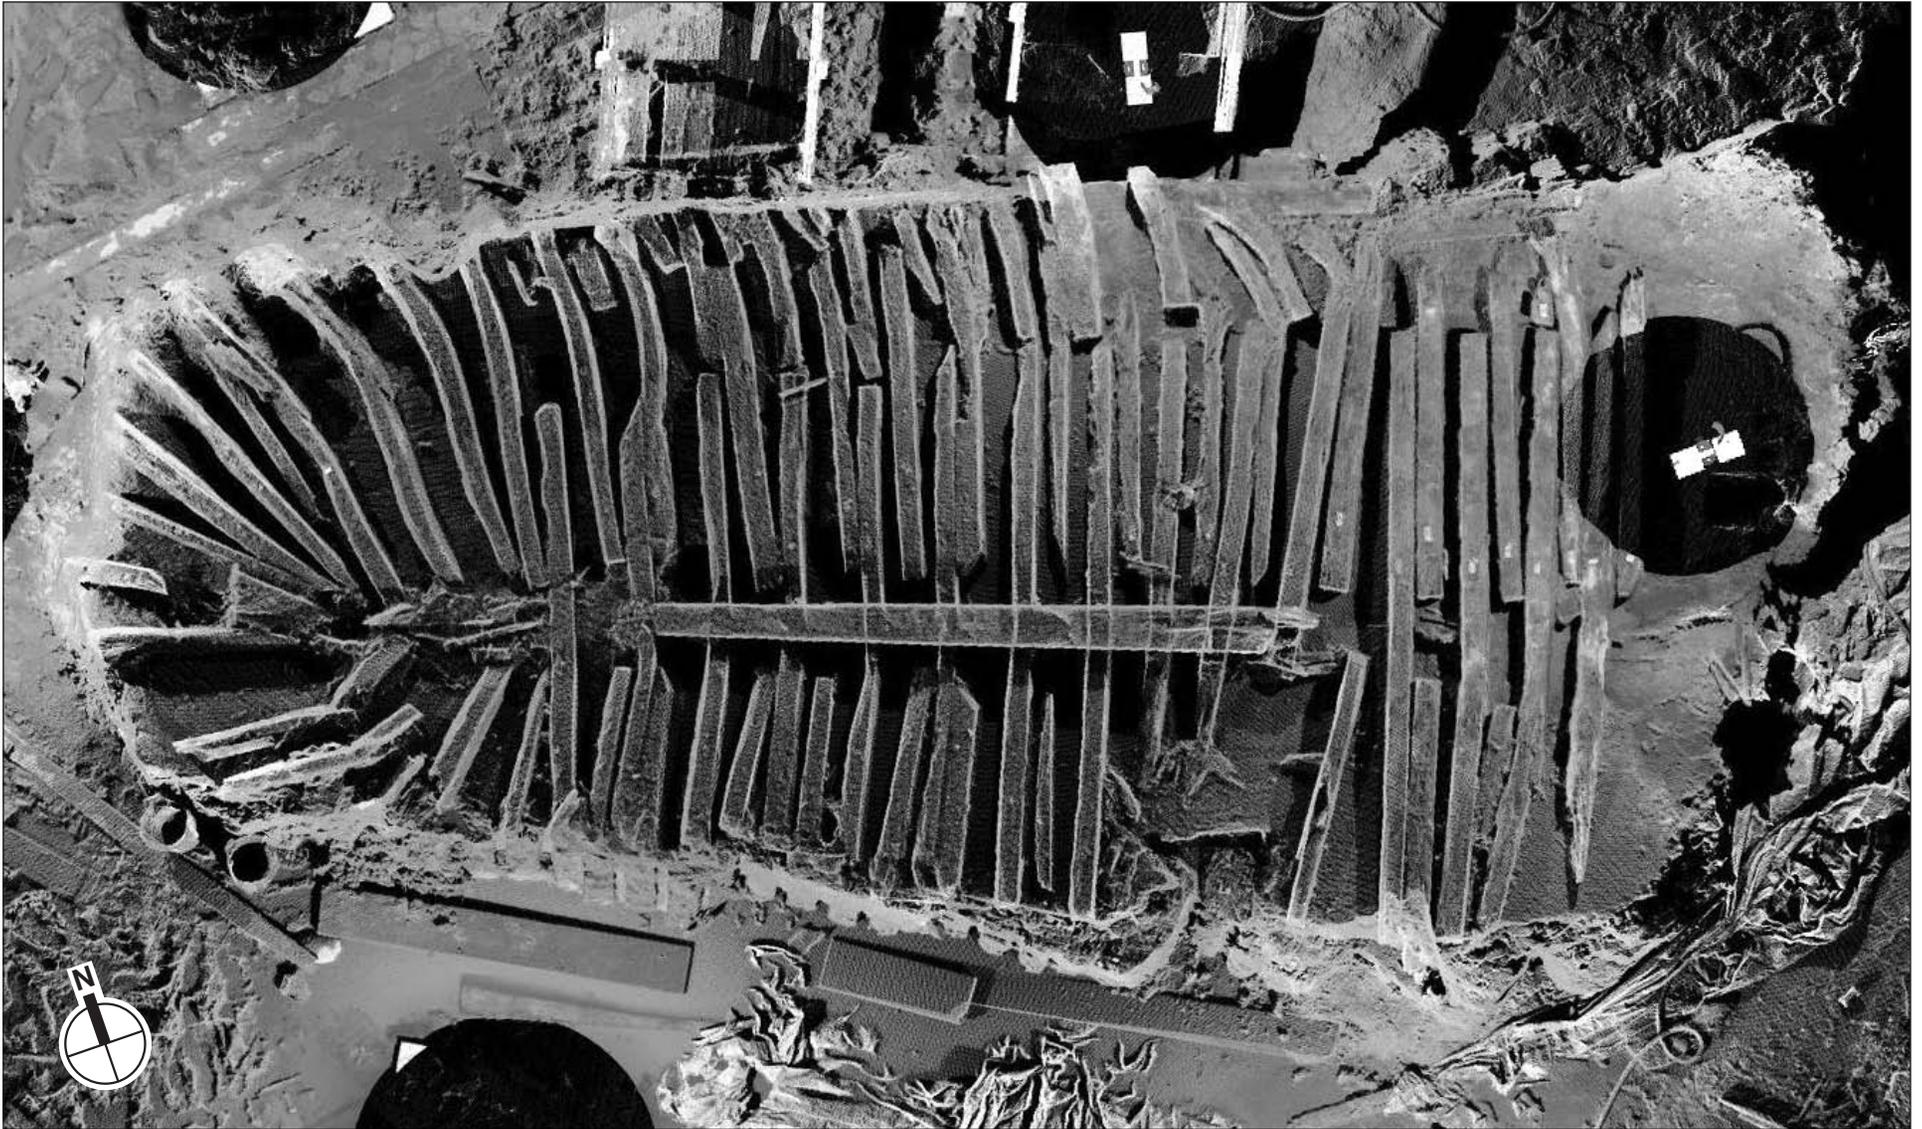
Laser Scan of Frames of the Stern
Figure 5-3b

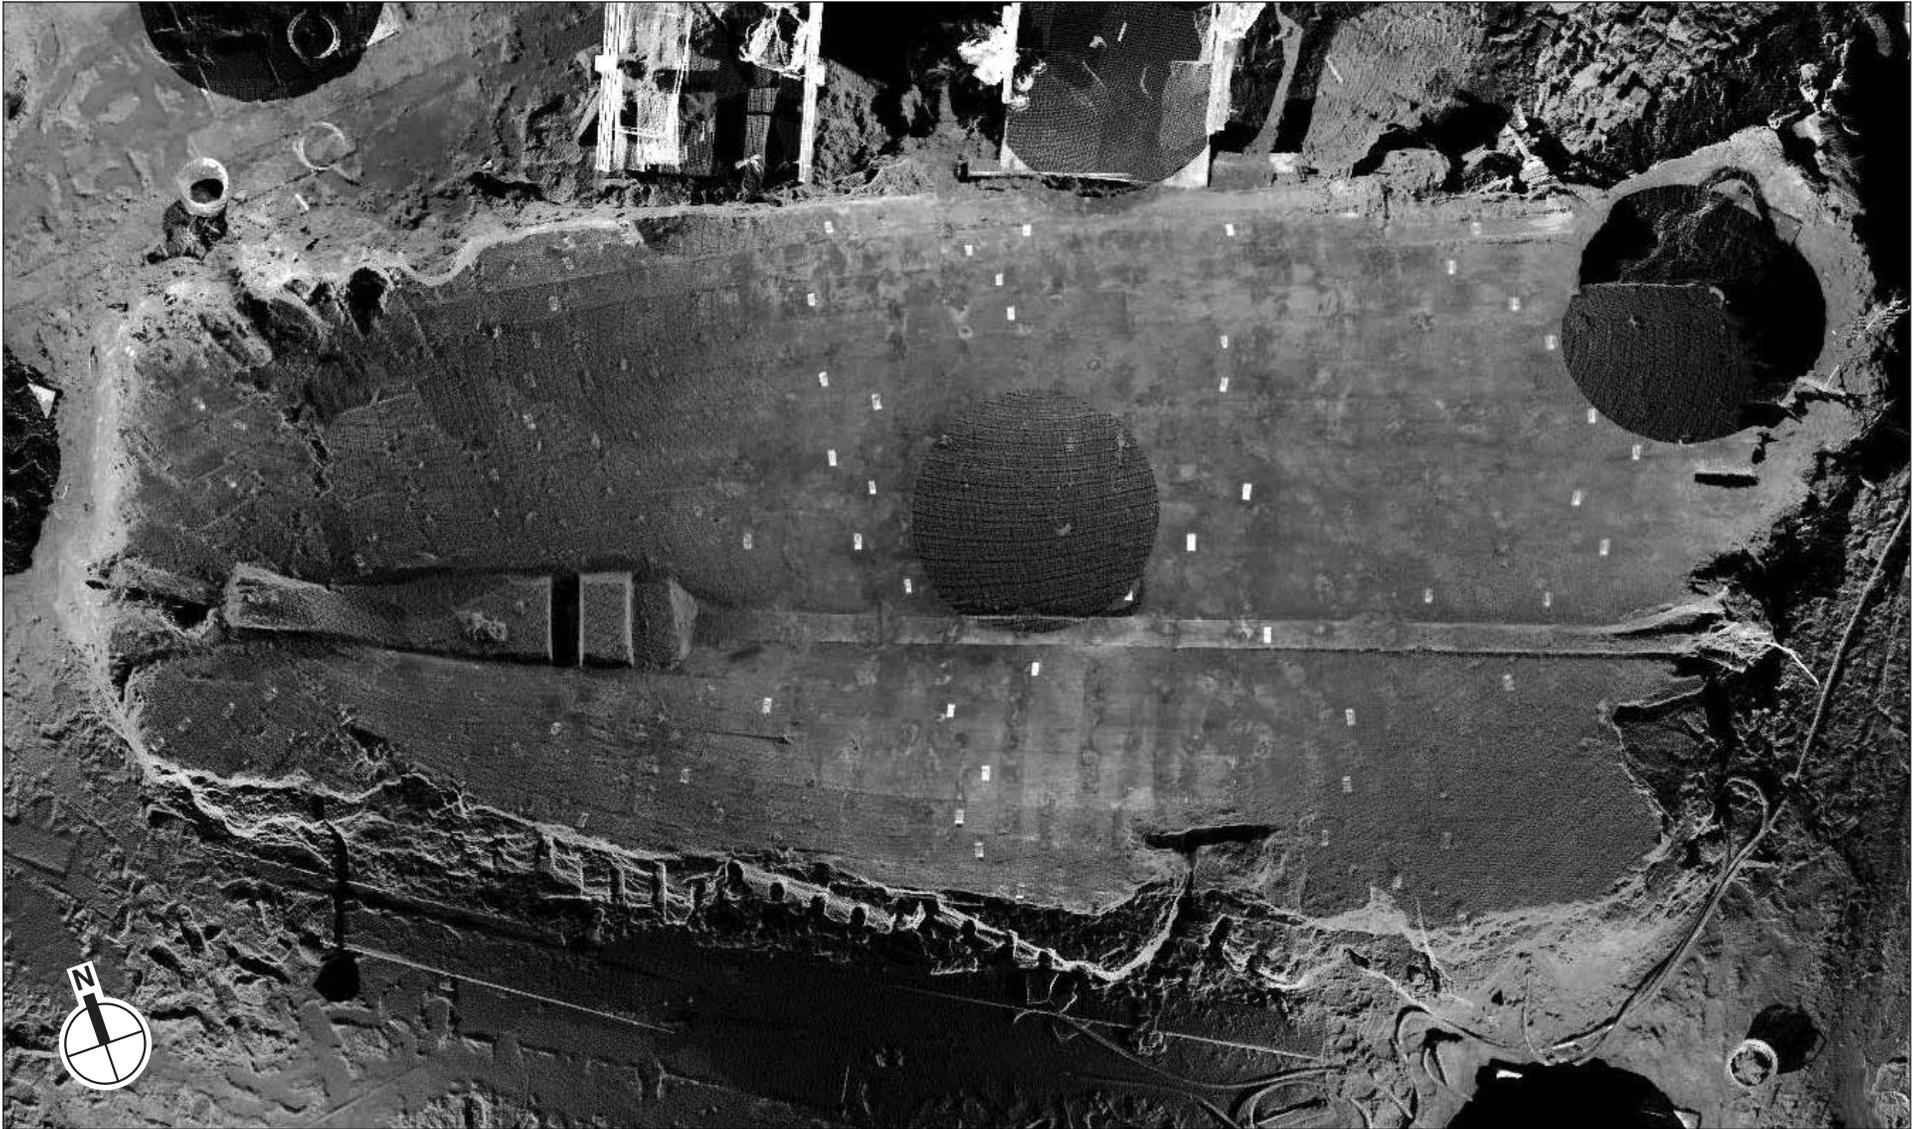
Laser Scan of the Outer Planking of the Stern
Figure 5-3c

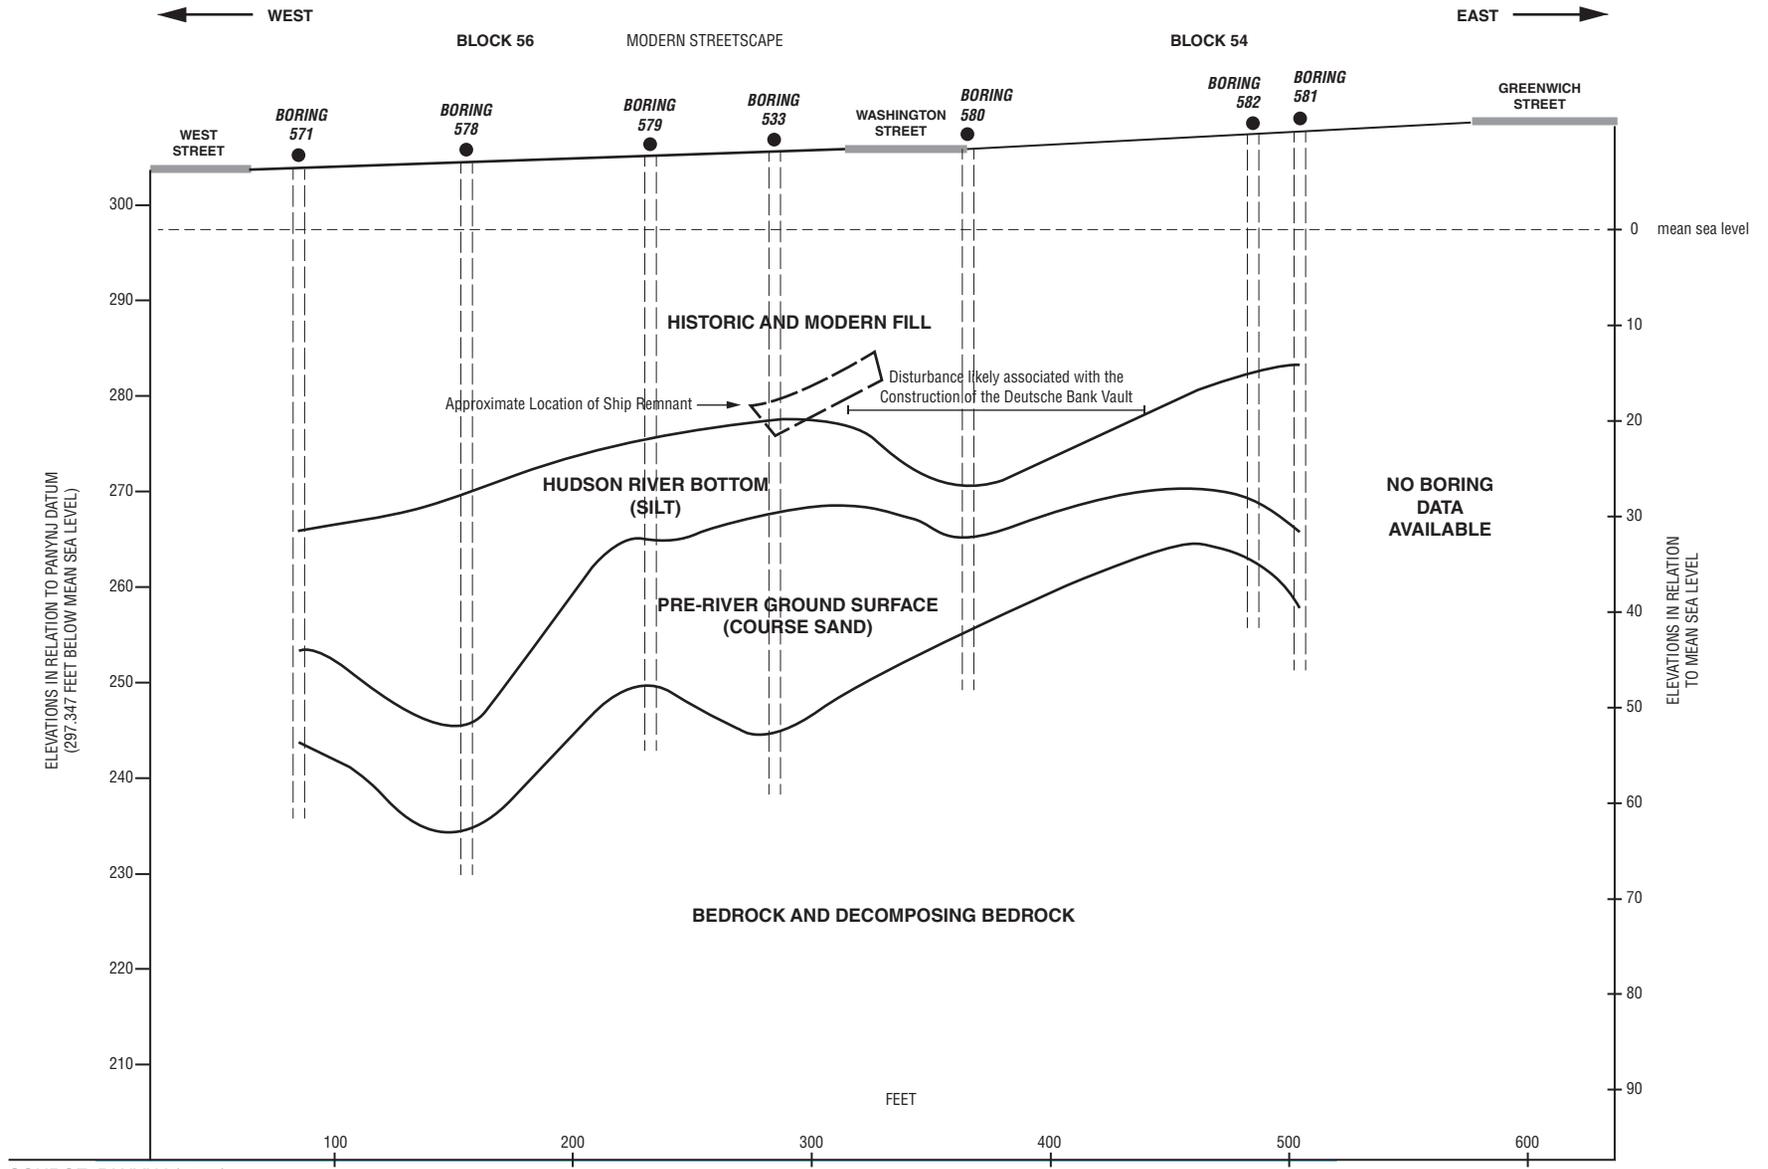
NOTES: This profile was generated using selected soil boring logs. In some cases, soil levels observed in the borings have been combined. This profile therefore represents an estimate of what the general profile of the site may have looked like and has been simplified for the purposes of this analysis. Vertical and horizontal scale are different.

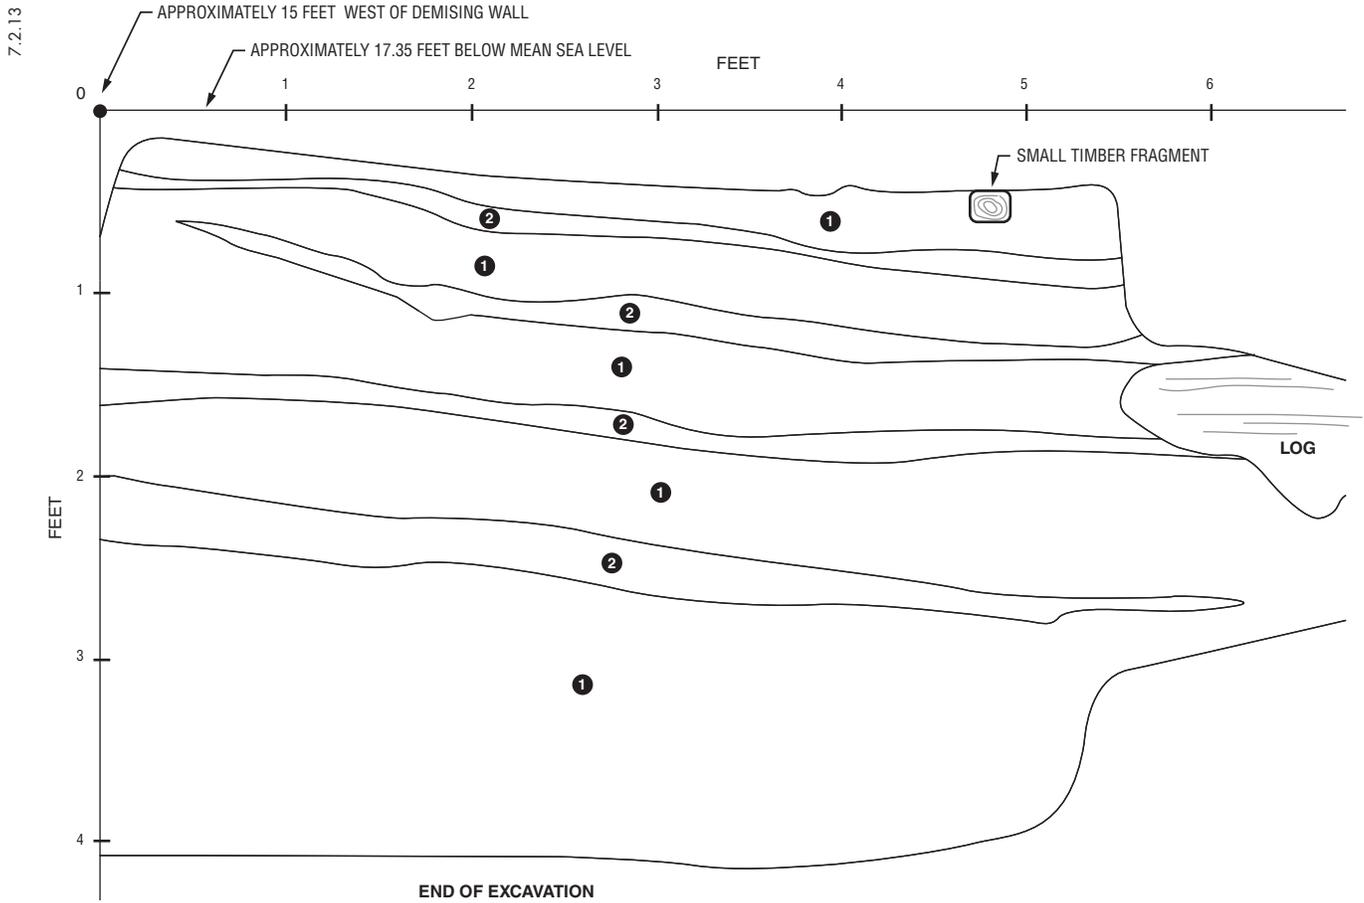
- ① 10YR 3/1 very dark gray dense silty clay mottled with 10YR 3/2 very dark grayish brown clay
- ② 10YR 4/3 brown fine silty sand with pebbles and small shells, streaked with lenses of soil 1

Profile drawing, north face of soil pedestal after removal of ship remnant **A**

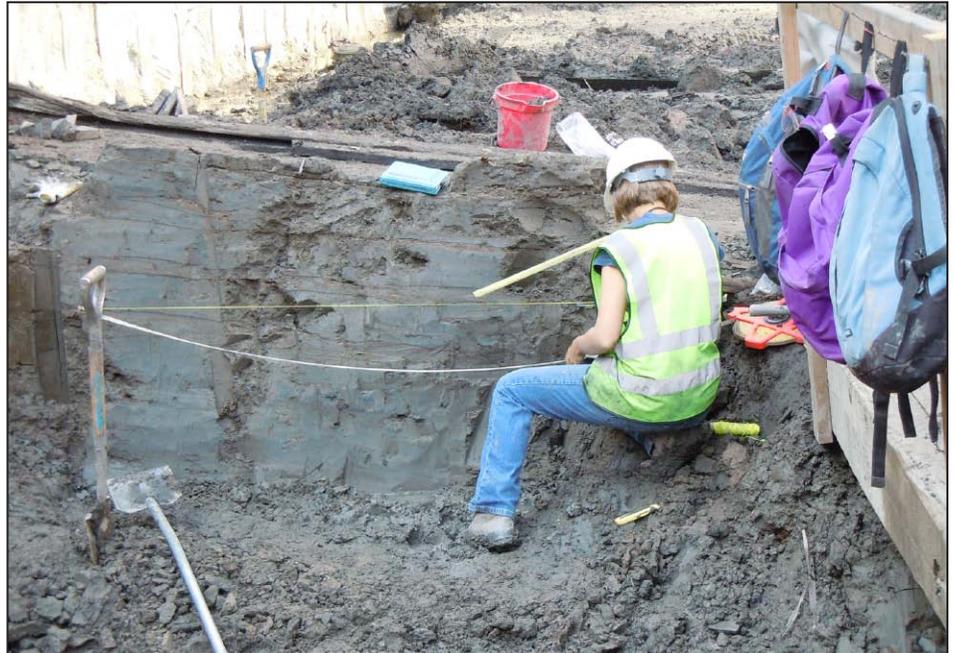
Photograph of north face of soil pedestal after removal of ship remnant **B**

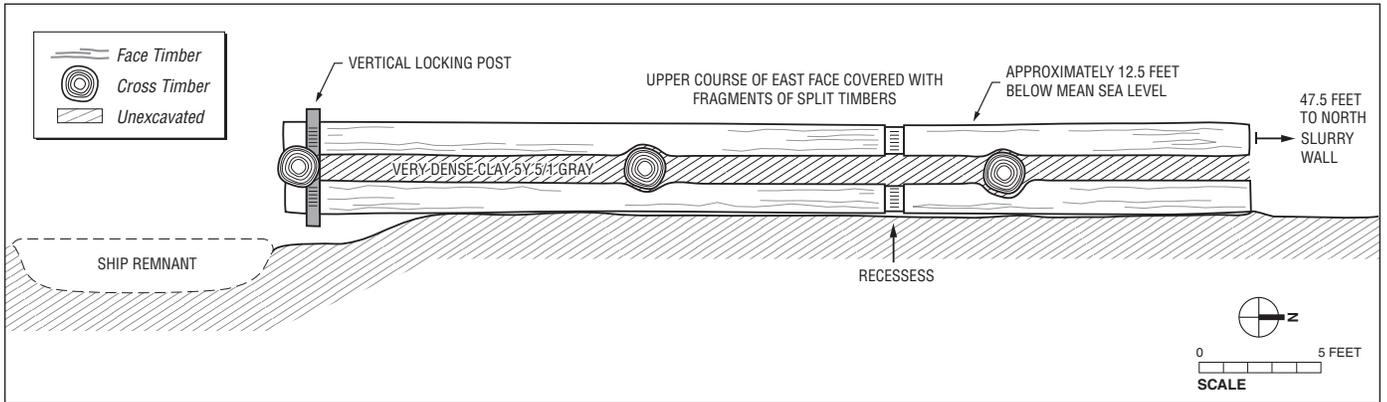
Profile drawing of east face of landfill retaining structure north of ship remnant **A**

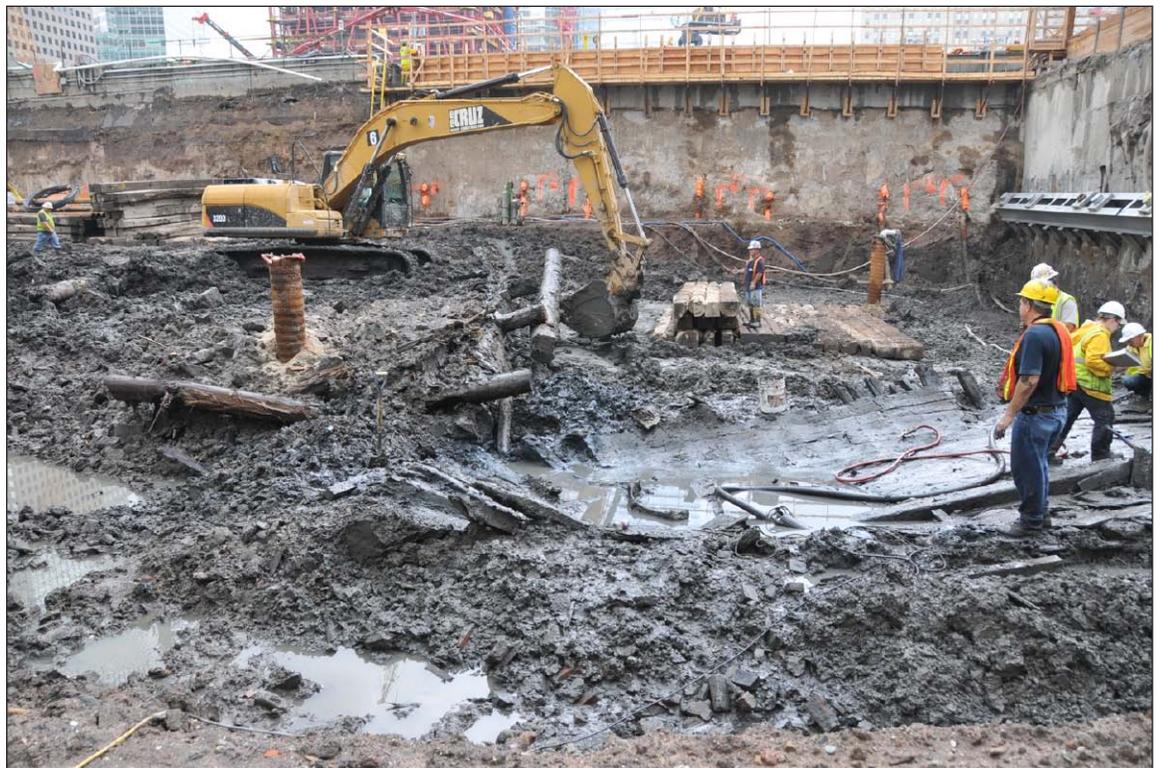
Facing north during removal of top course of landfill retaining structure north of ship remnant (in foreground). WTC slurry wall is in background and demising wall is to the right **B**

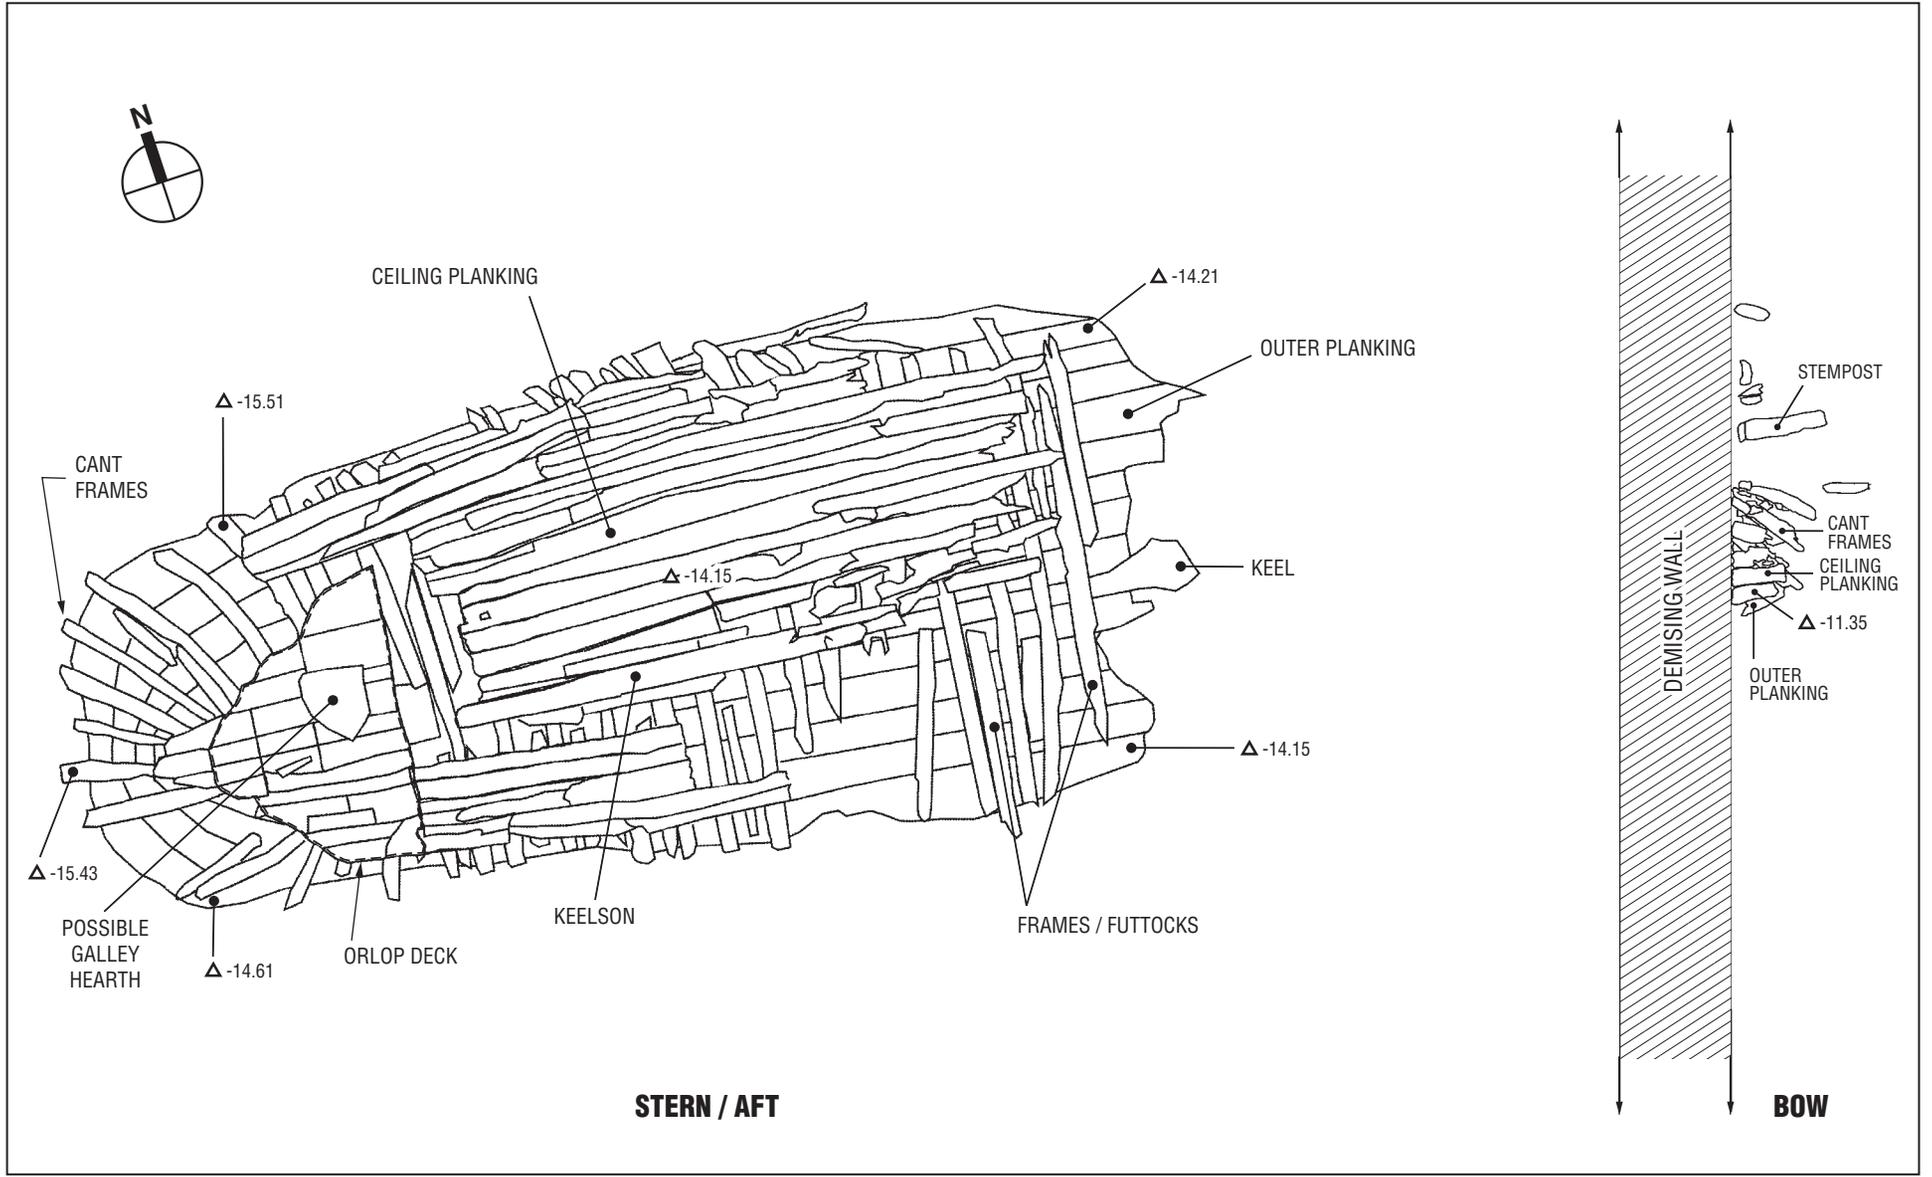
Plan View Drawing of Stern and Bow Portions of Ship Remnant
Figure 6-1
