Final Technical Report

**World Trade Center Memorial and Development Plan:
Data Recovery and Analysis of the WTC Ship**

**Blocks 54, Lot 1 and Block 56, Lots 15, 20, and 21
New York, New York**

August 2013

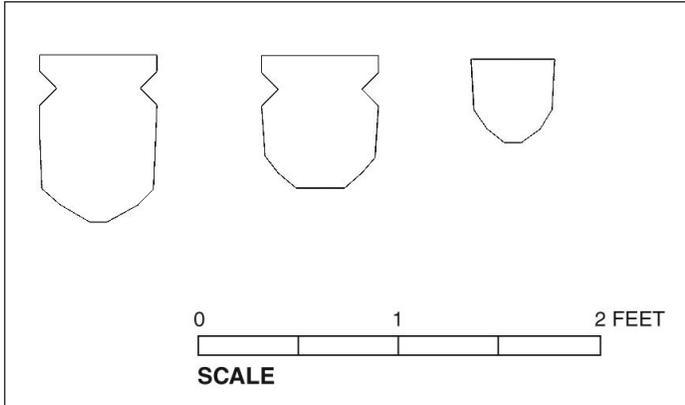
Cross sections of keel from near amidships (left) to stern (right) showing changes in rabbet

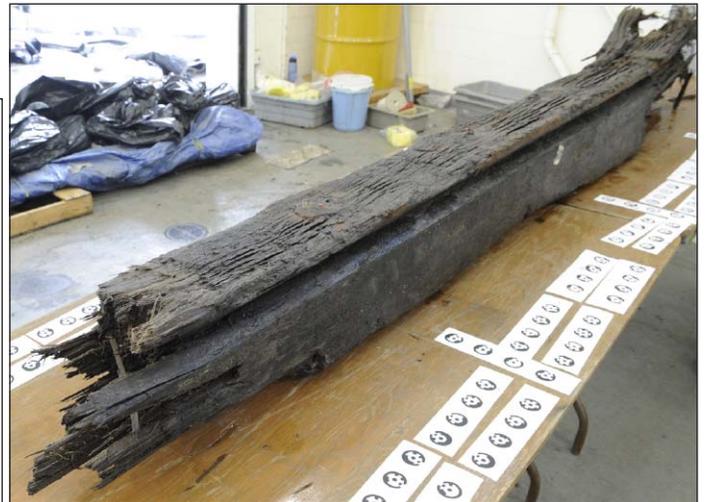
West half of intentionally broken keel showing 1.5-inch-deep rabbet. Photograph by Drew Fulton

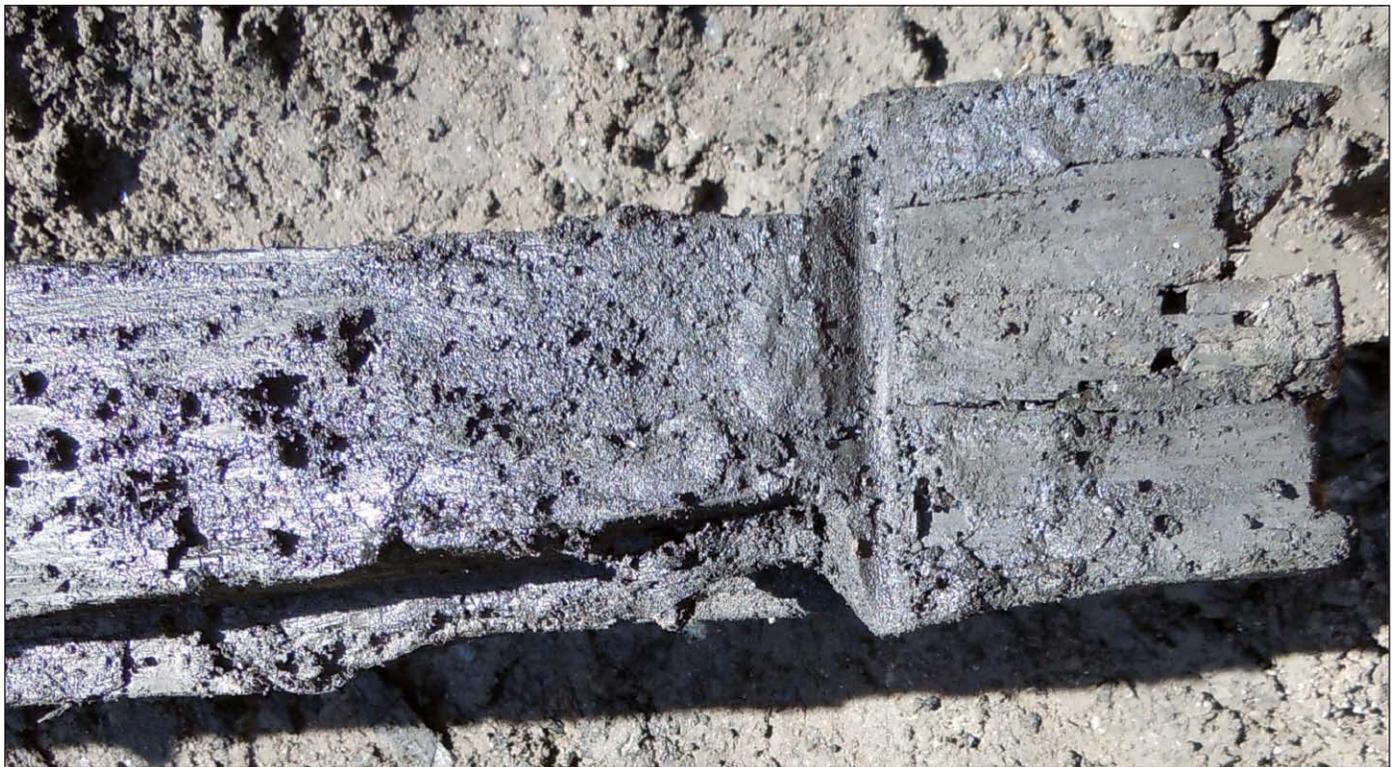
Aft end of keel as observed in the field

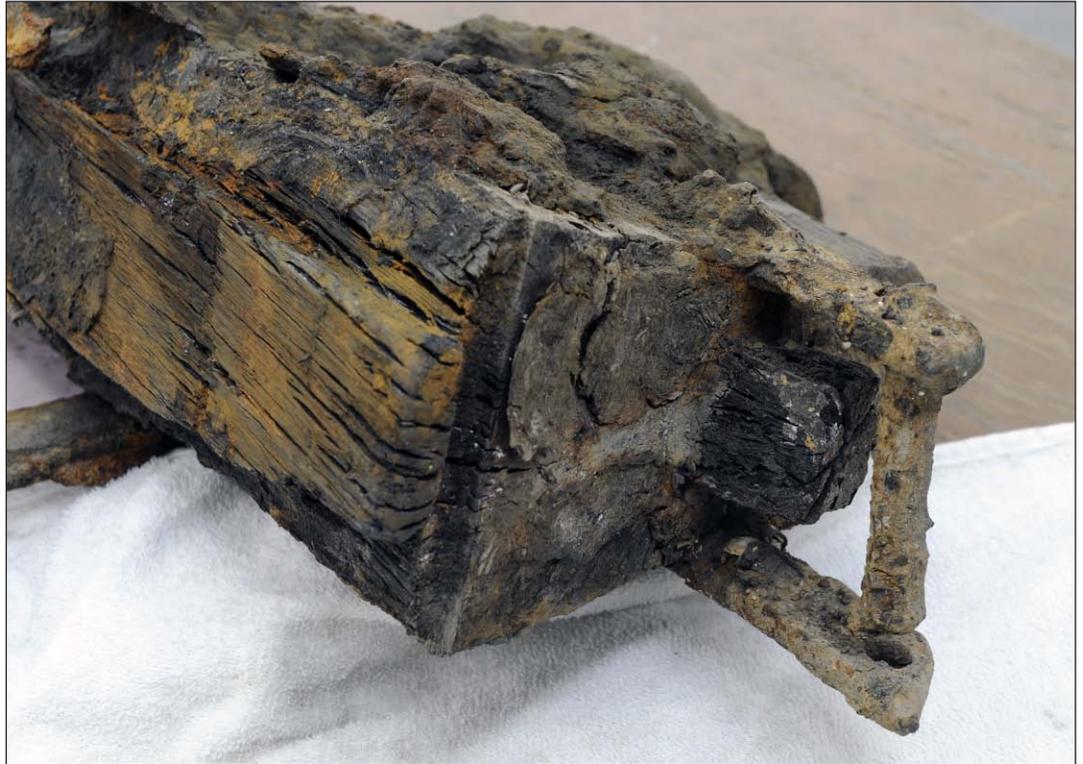
Bottom of sternpost (ST2), which attached to the keel with a projecting wood tenon and iron stirrup. The forward face is to the left of the photograph. Photograph by Drew Fulton

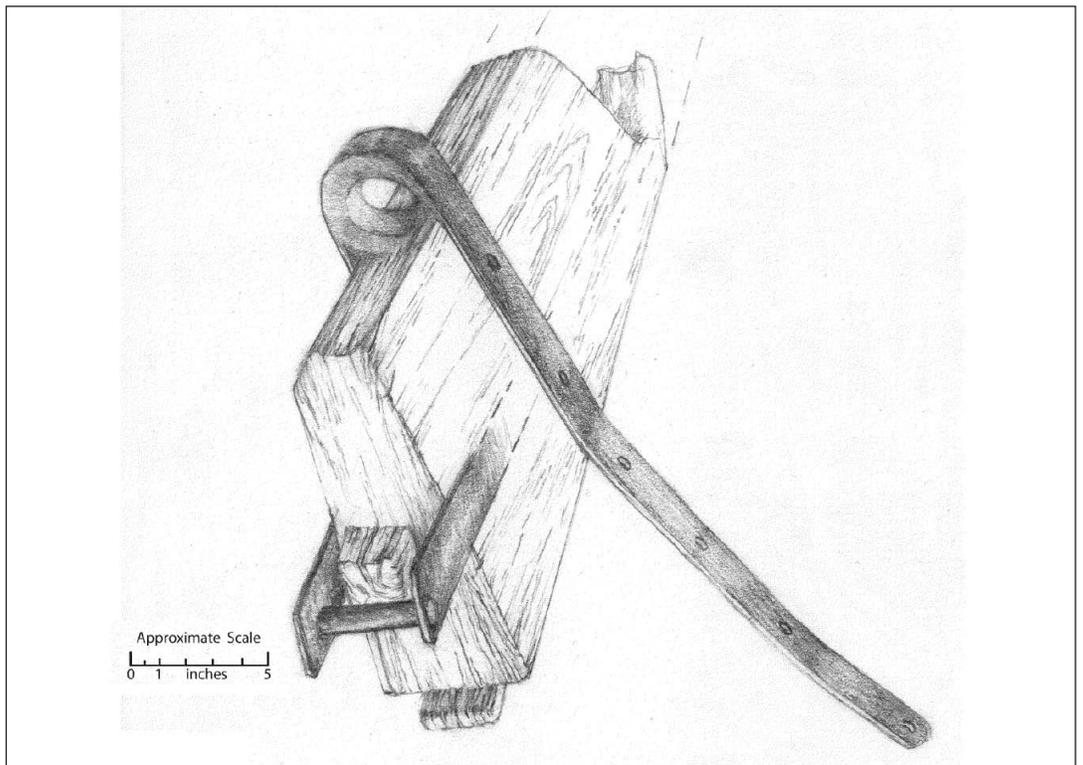
Artist's rendering of the bottom half of the sternpost by Kathleen Galligan. The circular gudgeon is located on the aft face of the sternpost

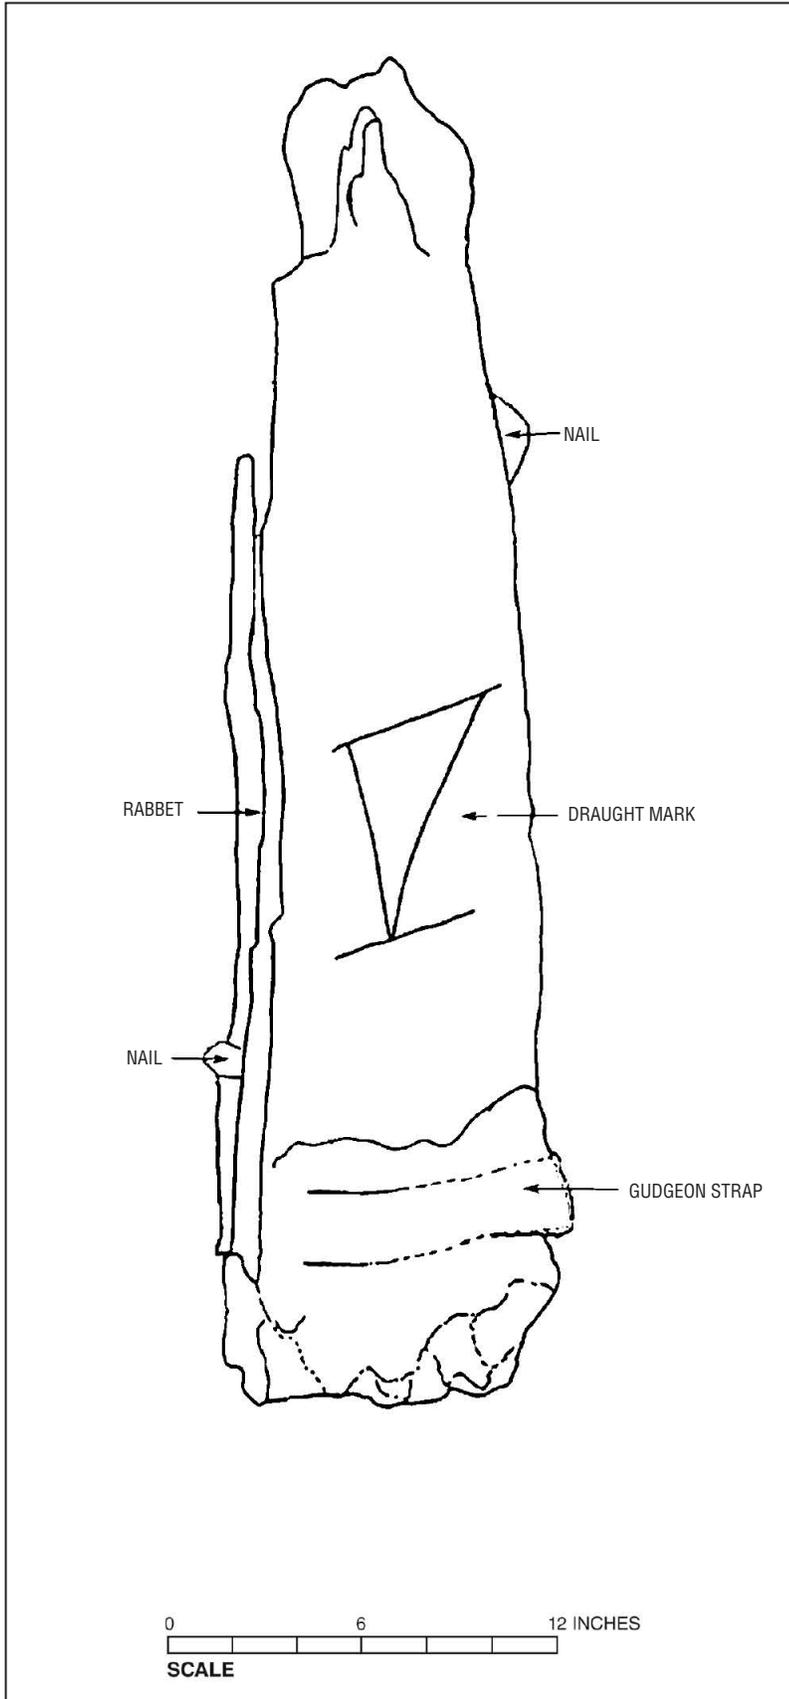
Tracing showing draught mark on port face of sternpost **A**

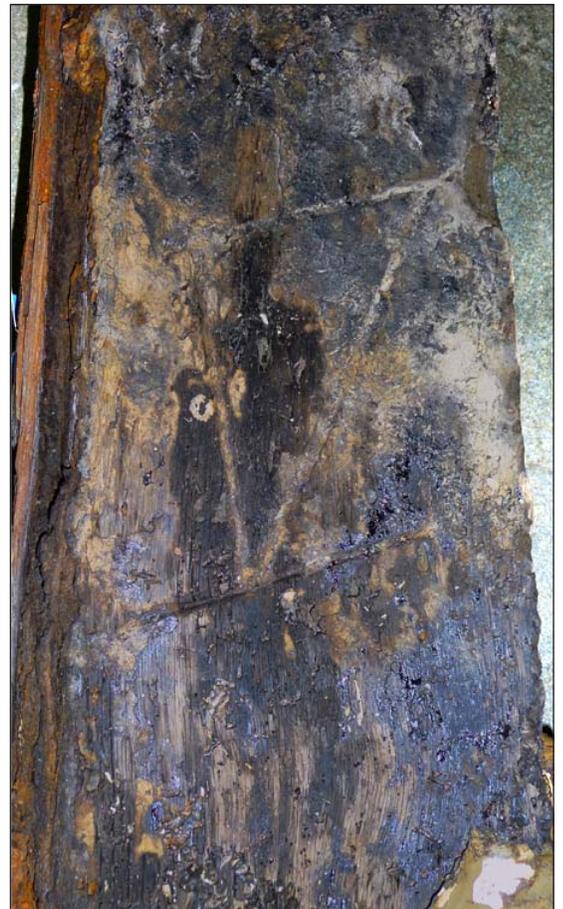
Photograph of draught mark on port face of sternpost **B**

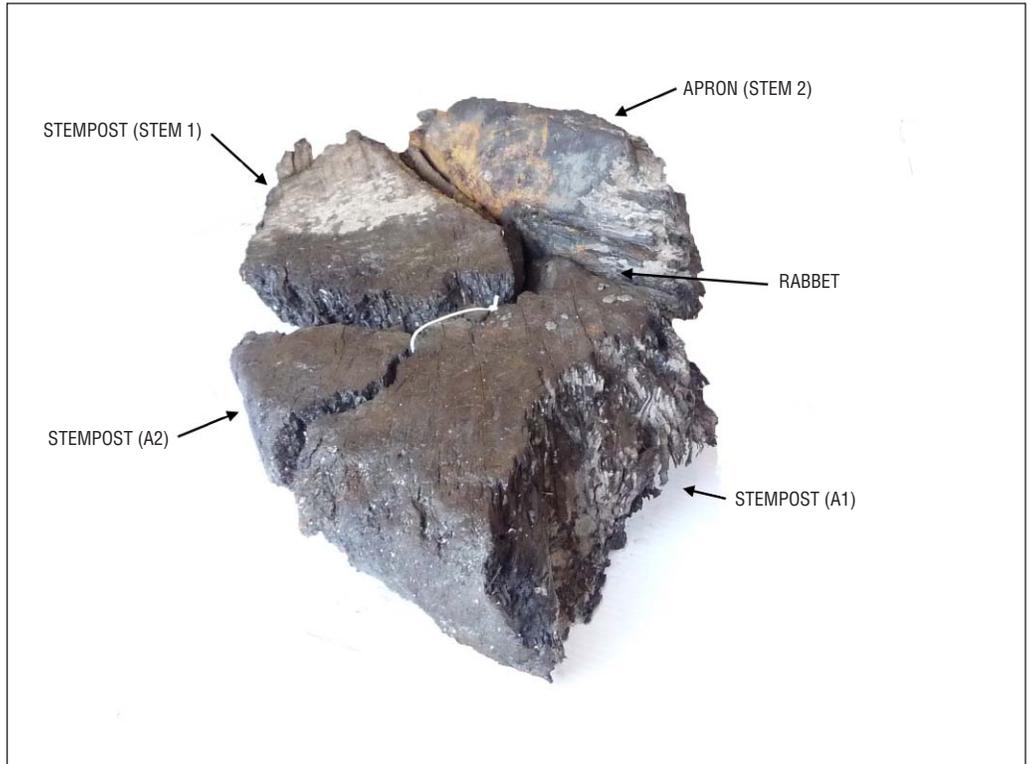
Stempost and apron viewed from the port side **A**

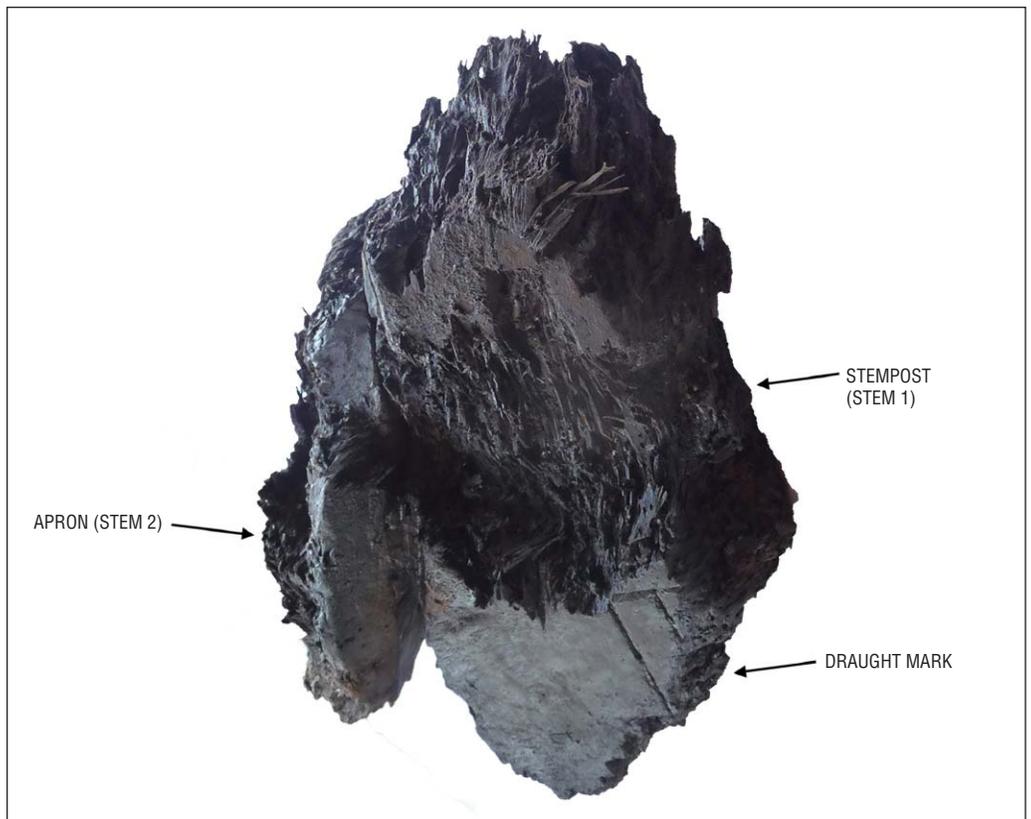
Stempost starboard draught mark (part of a Roman numeral II). The draught mark is at the base of the fragment that would have been connected to A2 **B**

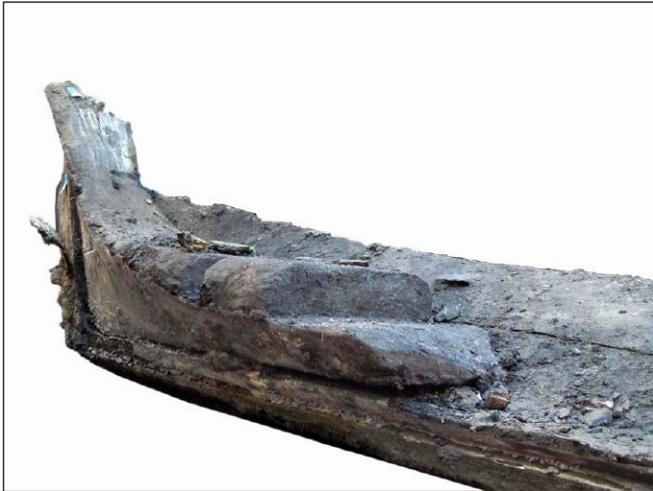
Stern knee as observed in field after removal of outer planking on starboard side (this photograph has been edited so that only the Ship Remnant is visible) **1**

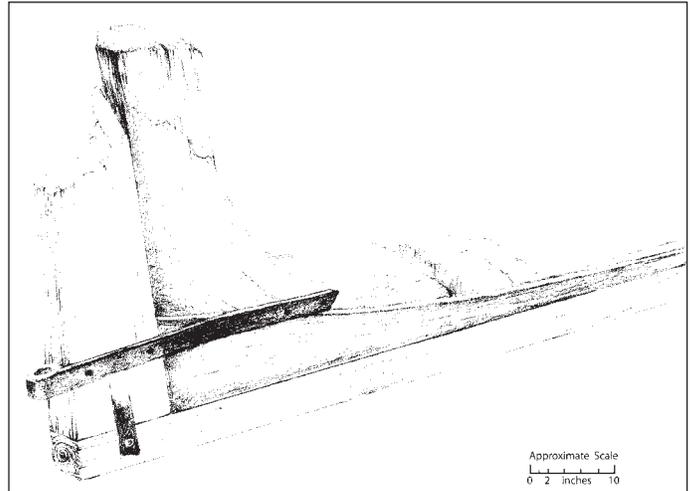
Artist's rendering of stern knee articulated with sternpost, keel, and outer planking. Drawing by Kathleen Galligan **2**

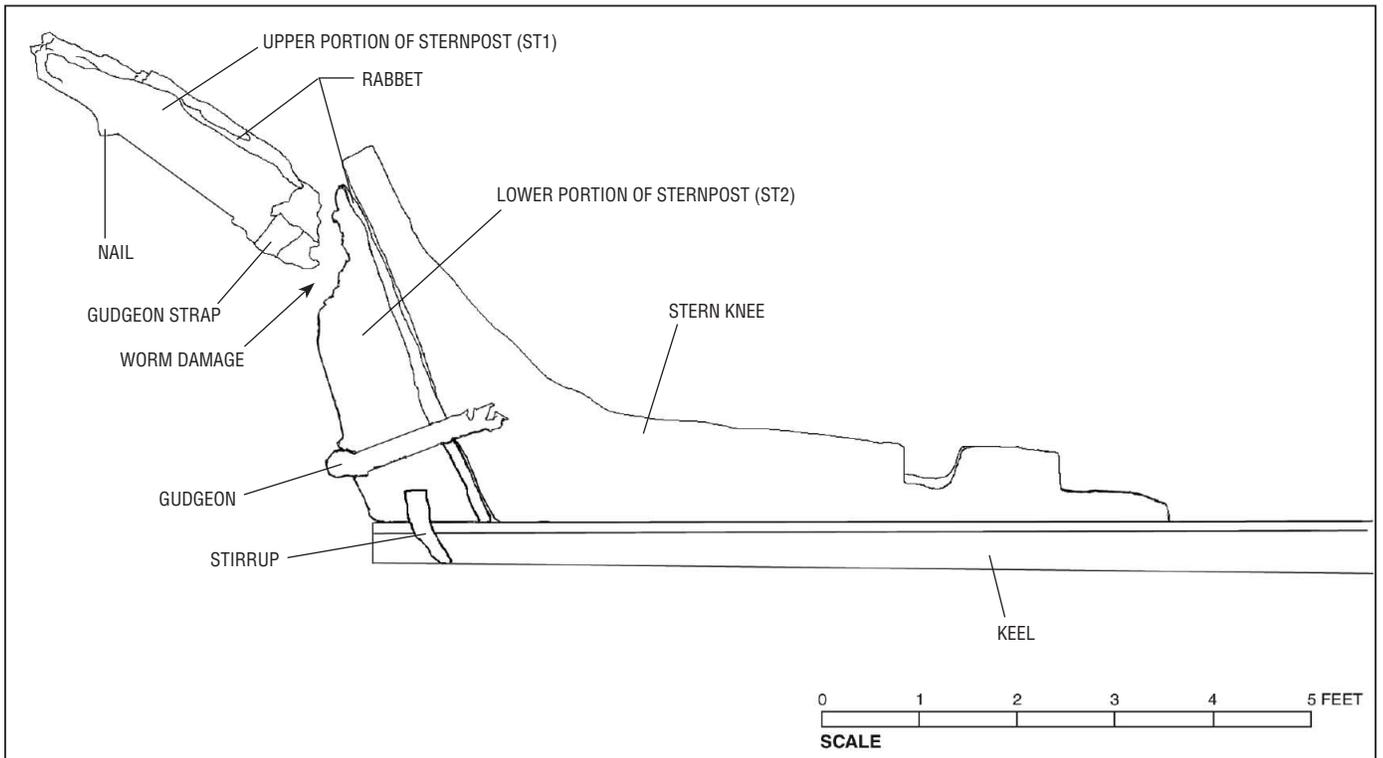
Composite sketch of sternpost, stern knee, and keel **3**

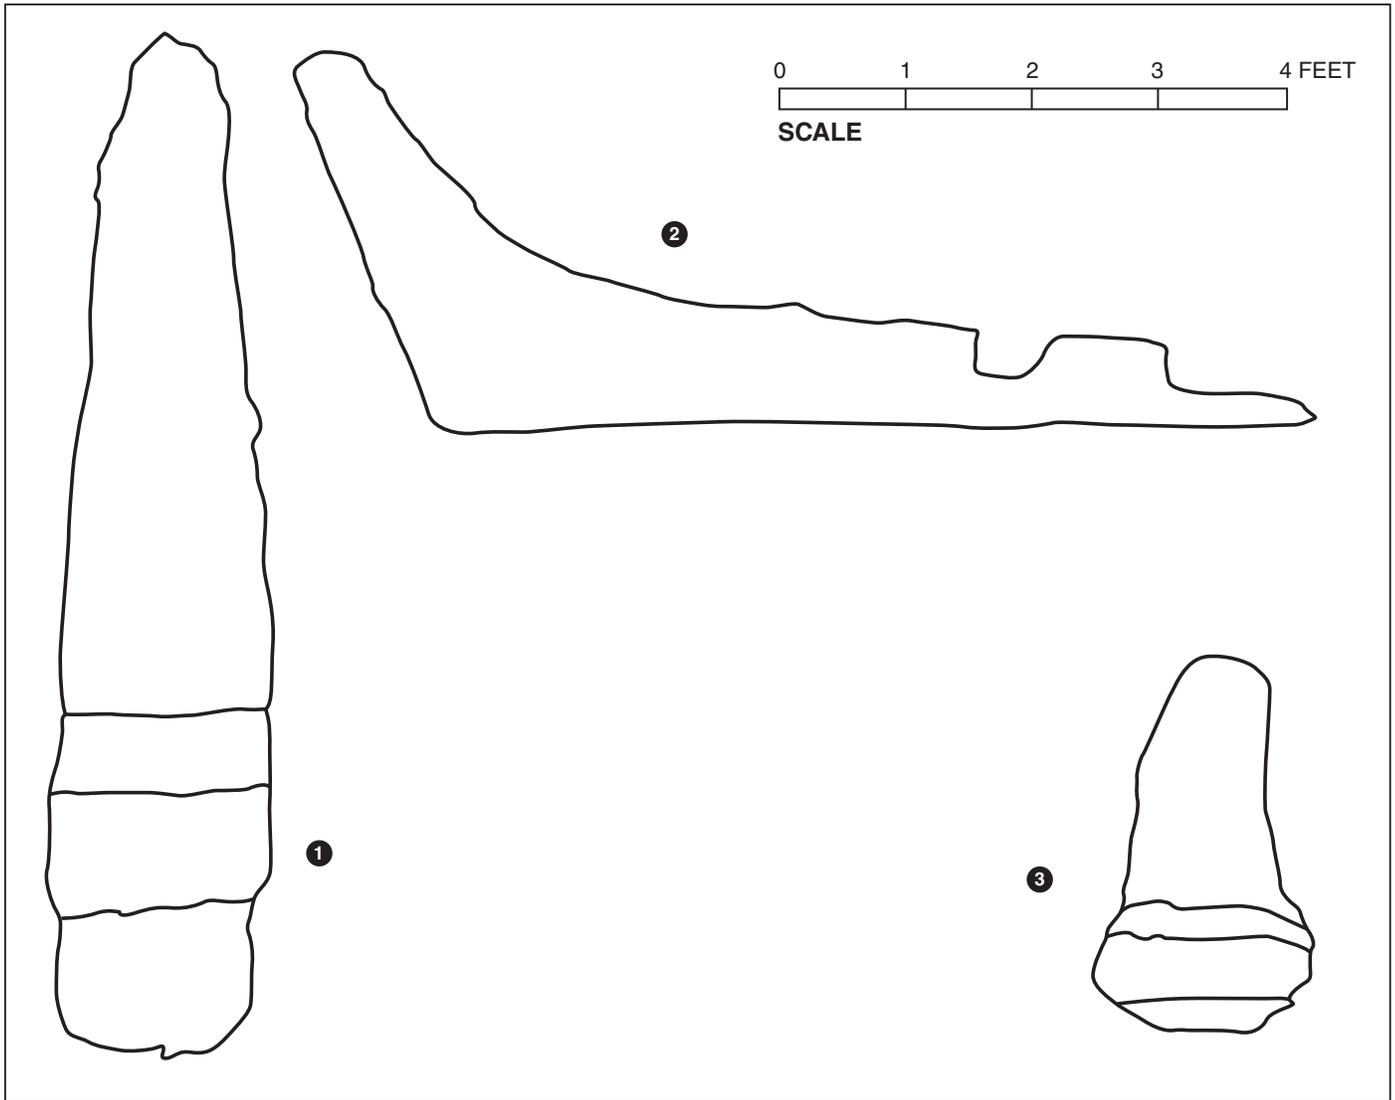
Top (1), starboard side (2), and forward side (3) views of stern knee. Images created using *Photo Modeler Scanner* and *Rhinorceros*

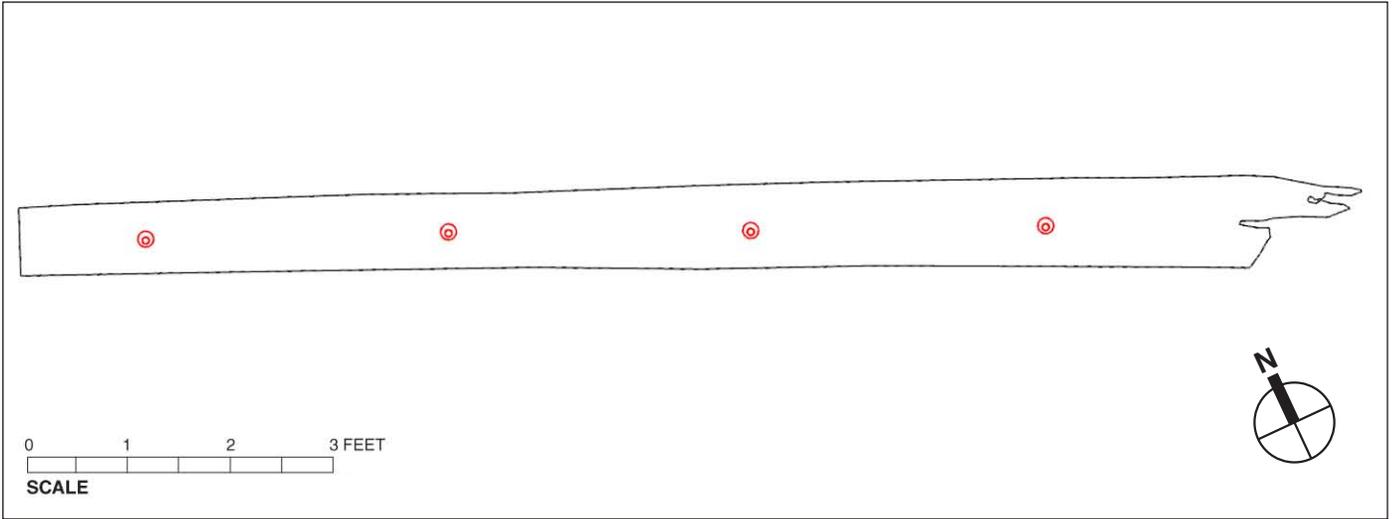
Schematic of top of keelson with nails marked in red. Image created using *Photo Modler Scanner* and *Rhinoceros* **A**

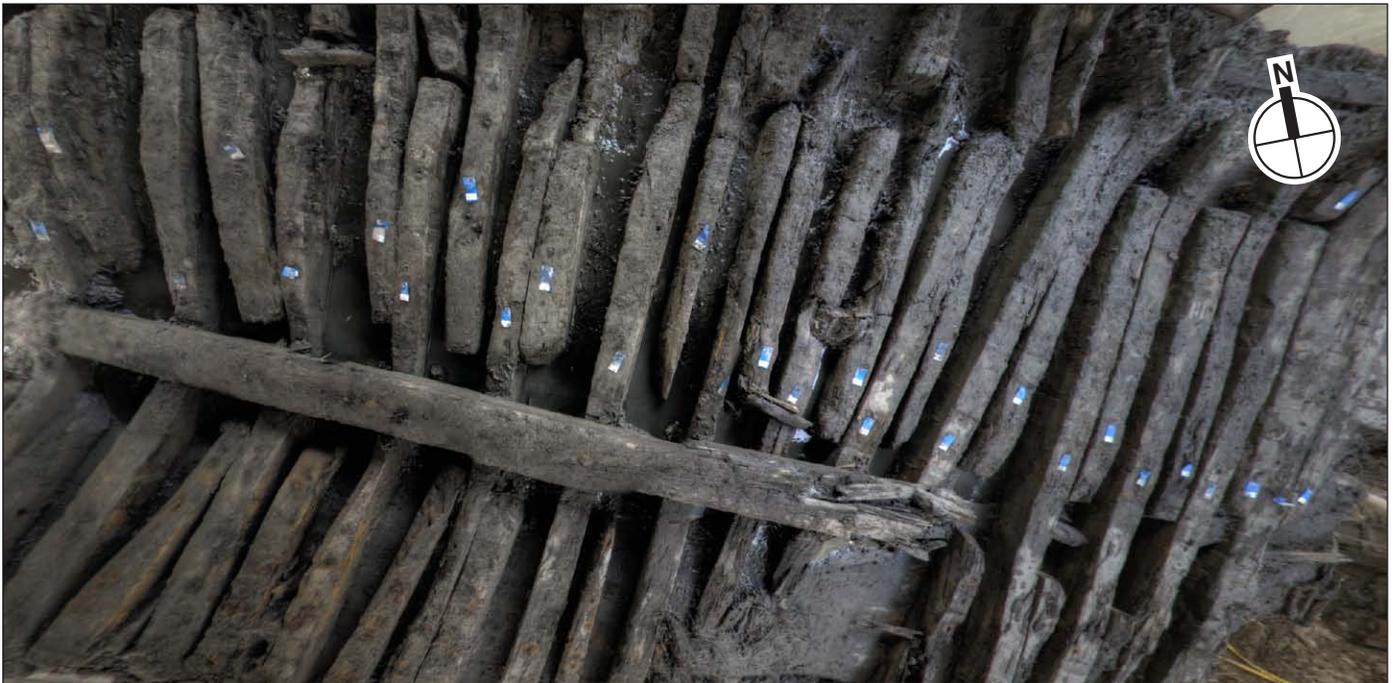
Photograph of keelson *in situ* after removal of ceiling planking. Photograph by Drew Fulton **B**

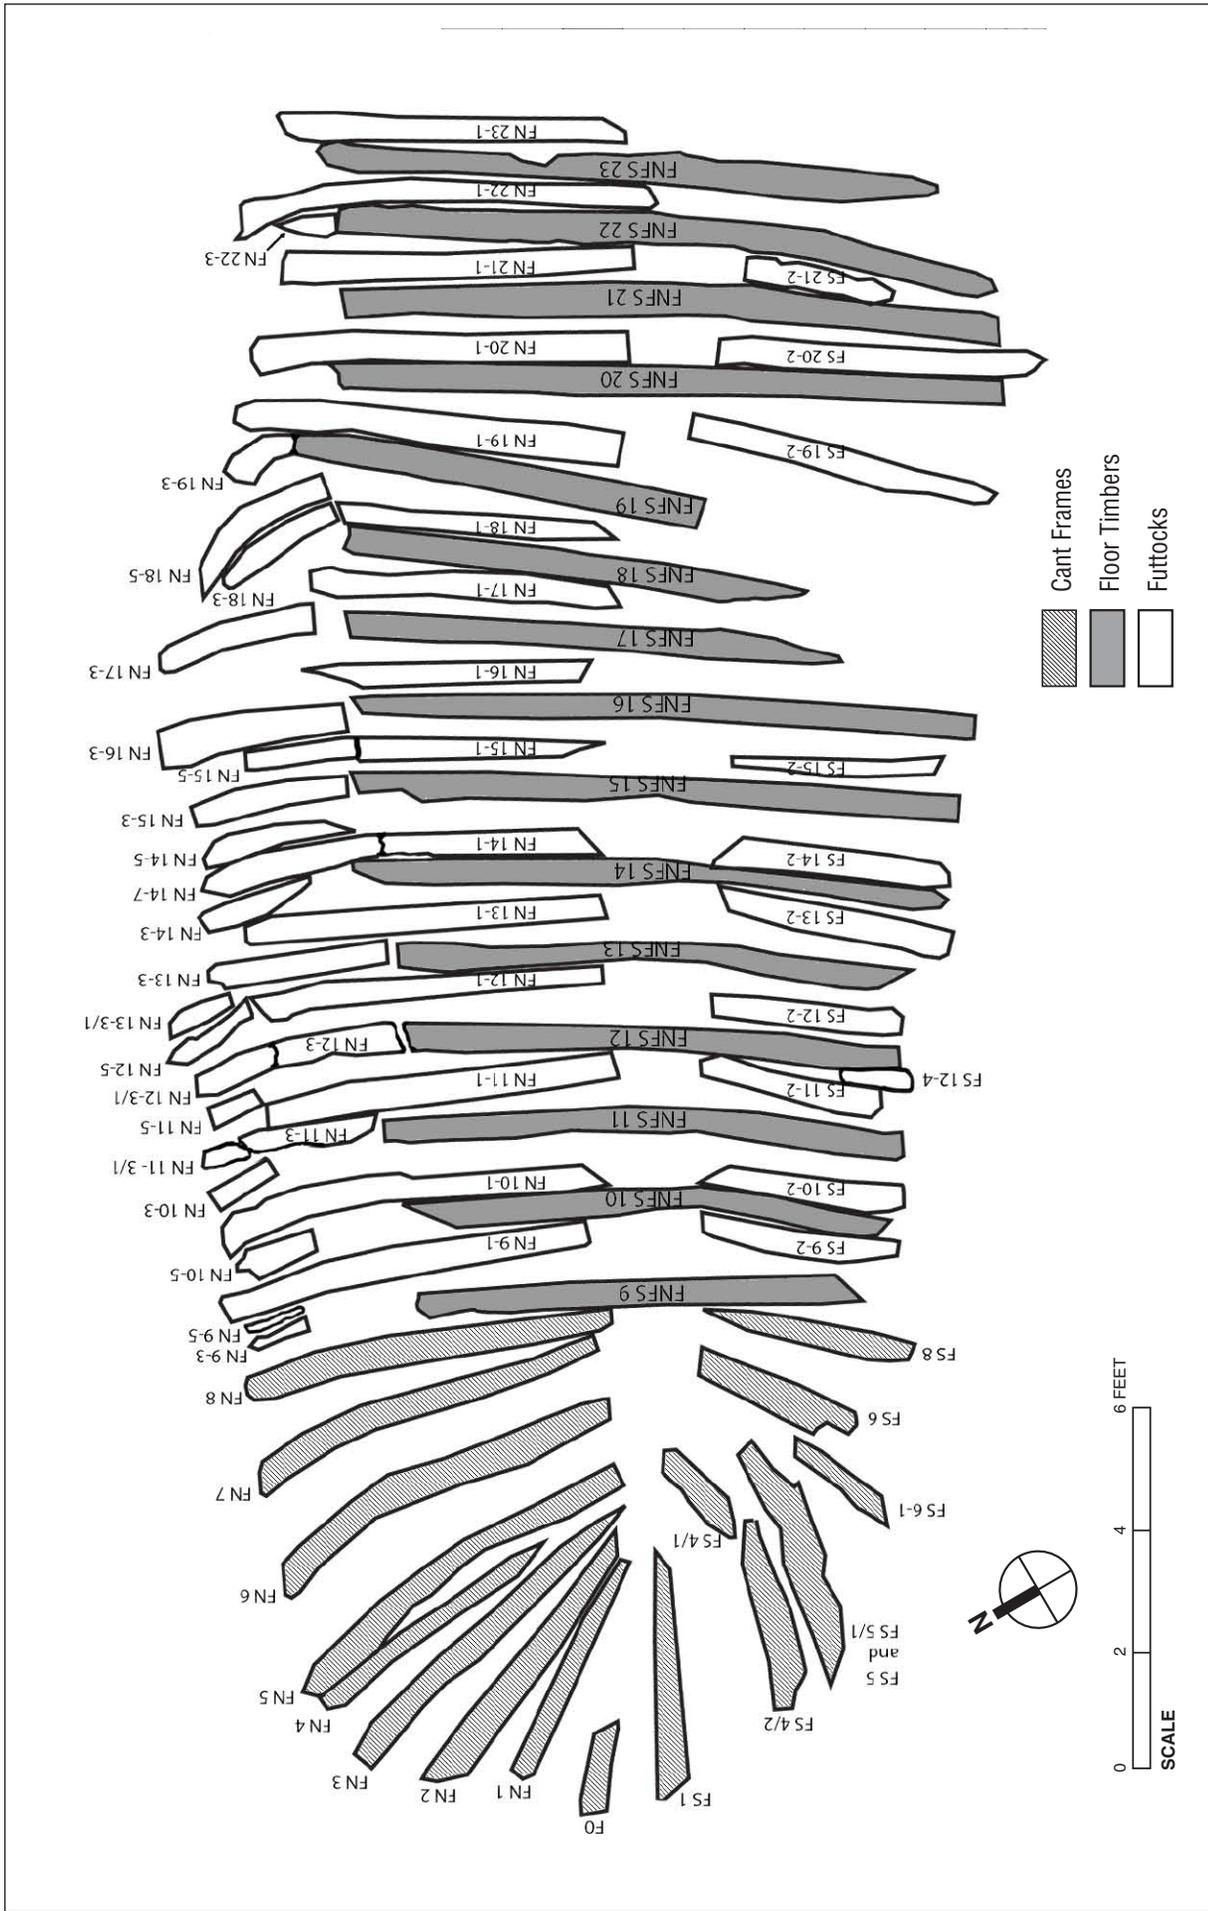
Plan View Drawing of
Frame Pattern of Stern
Figure 6-9

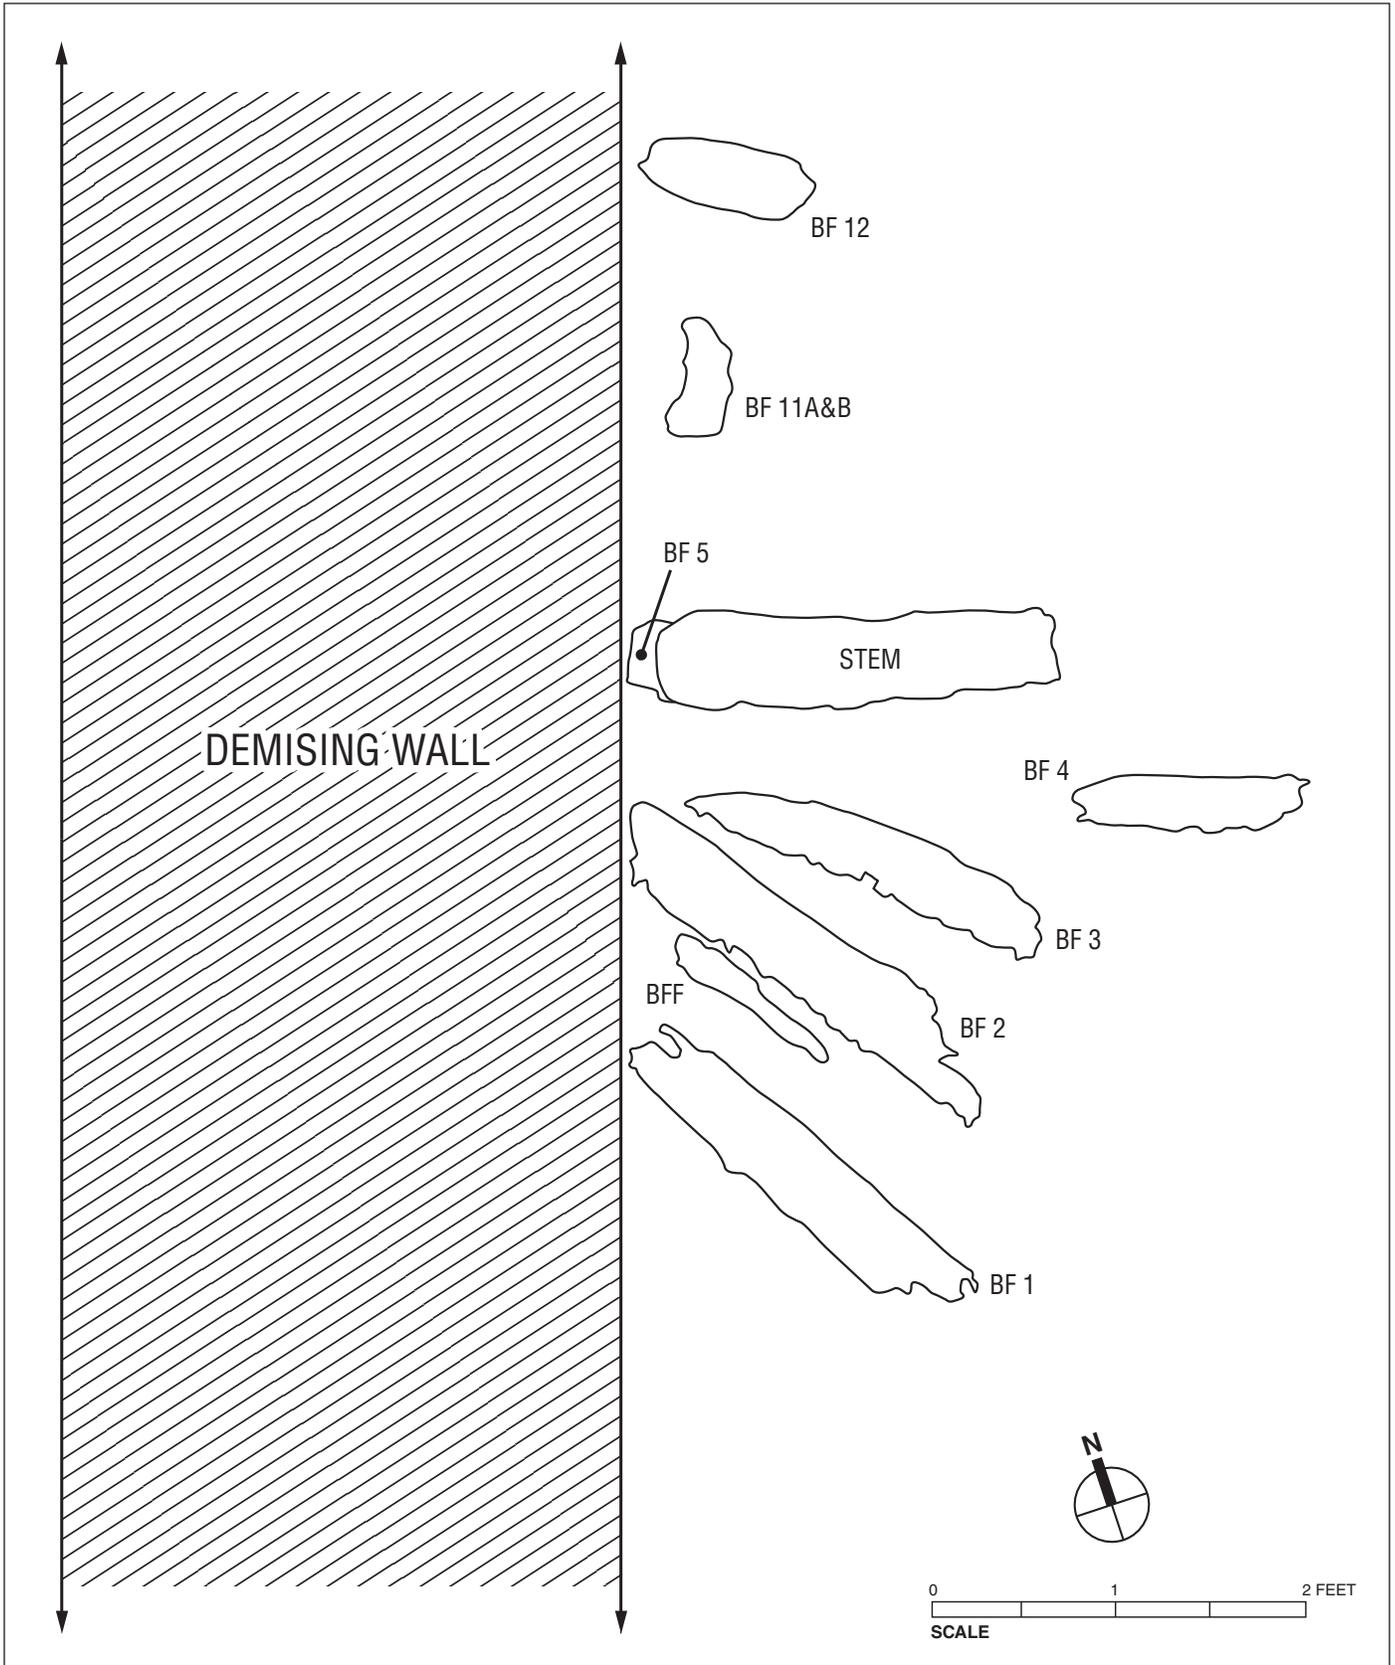
Plan View Drawing of Cant Frames of Bow

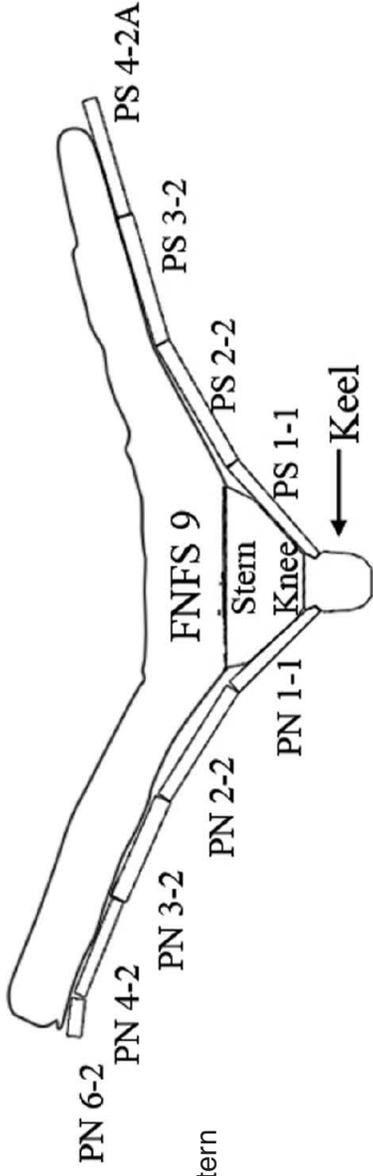
A Cross section near the stern

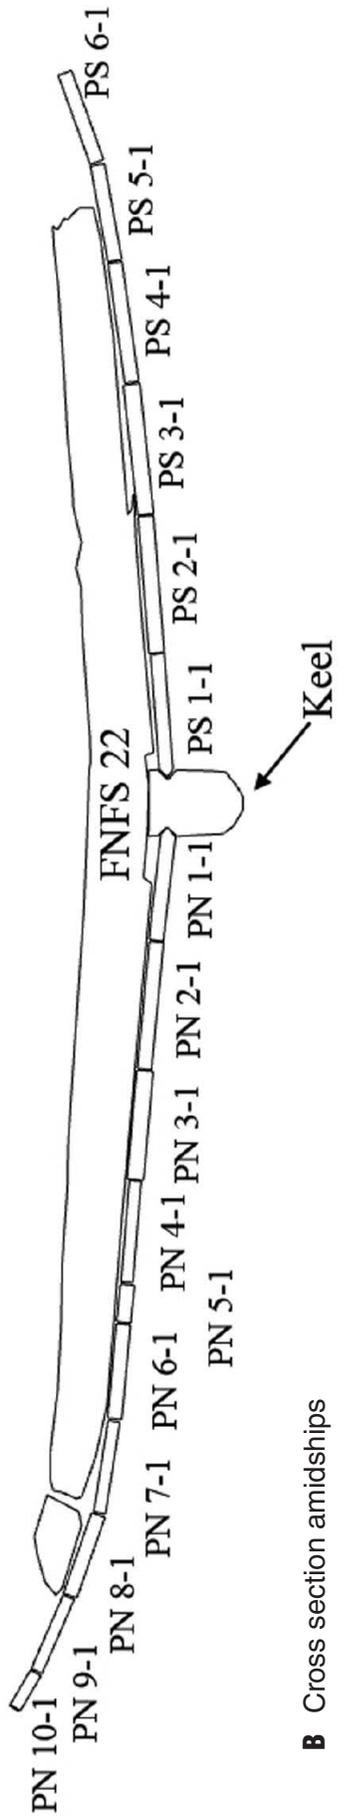
B Cross section amidships

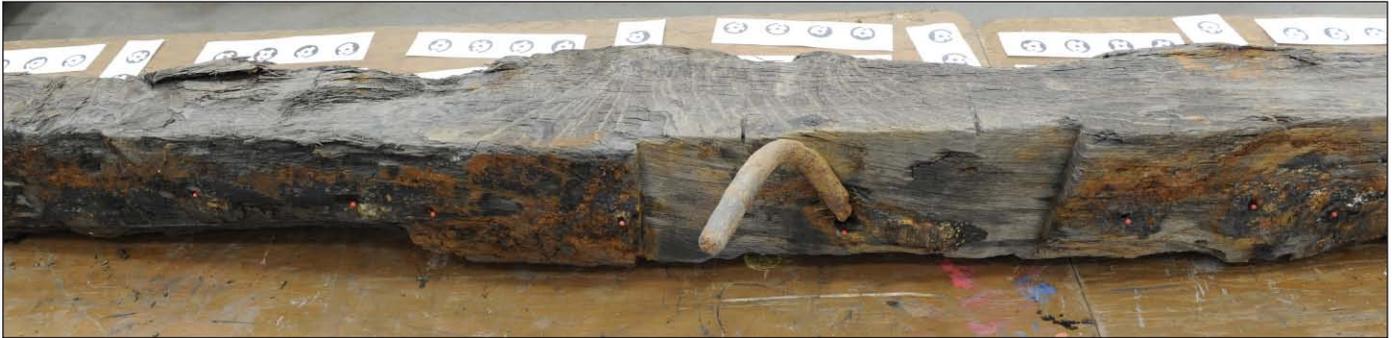
Frame FNFS 23-0 showing a mis-hit iron pin in center. Two marks on aft face of frame **A** correspond to location of keel. Photograph by Drew Fulton

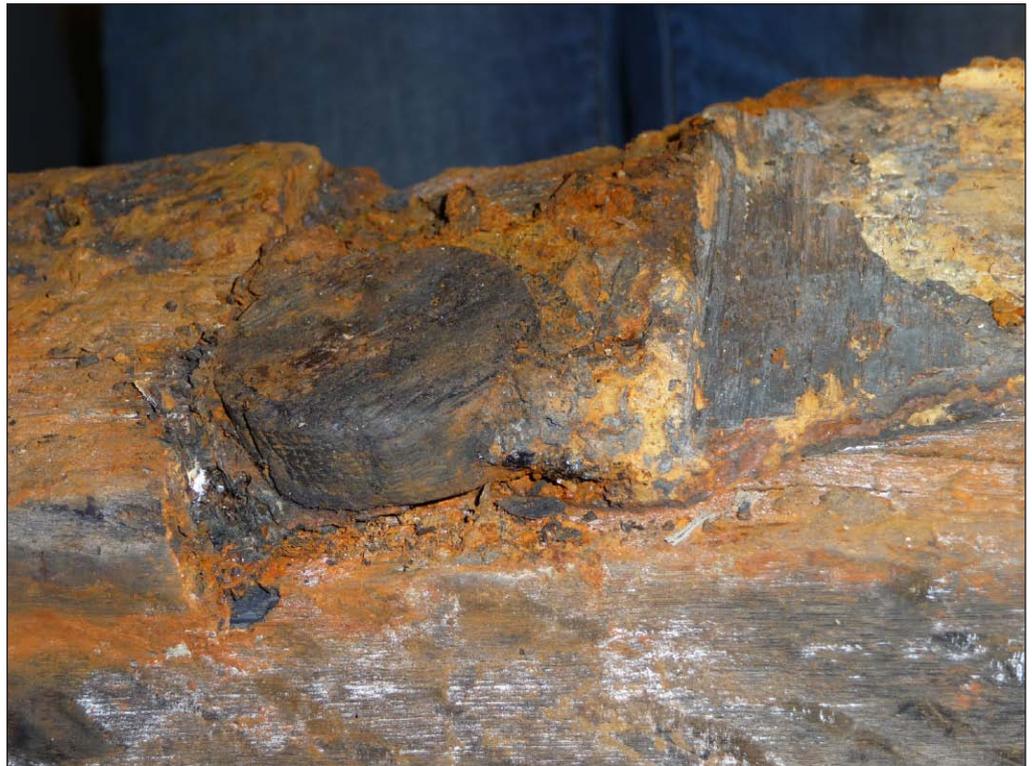
Filler plug located under frame FNFS 15-0 **B**

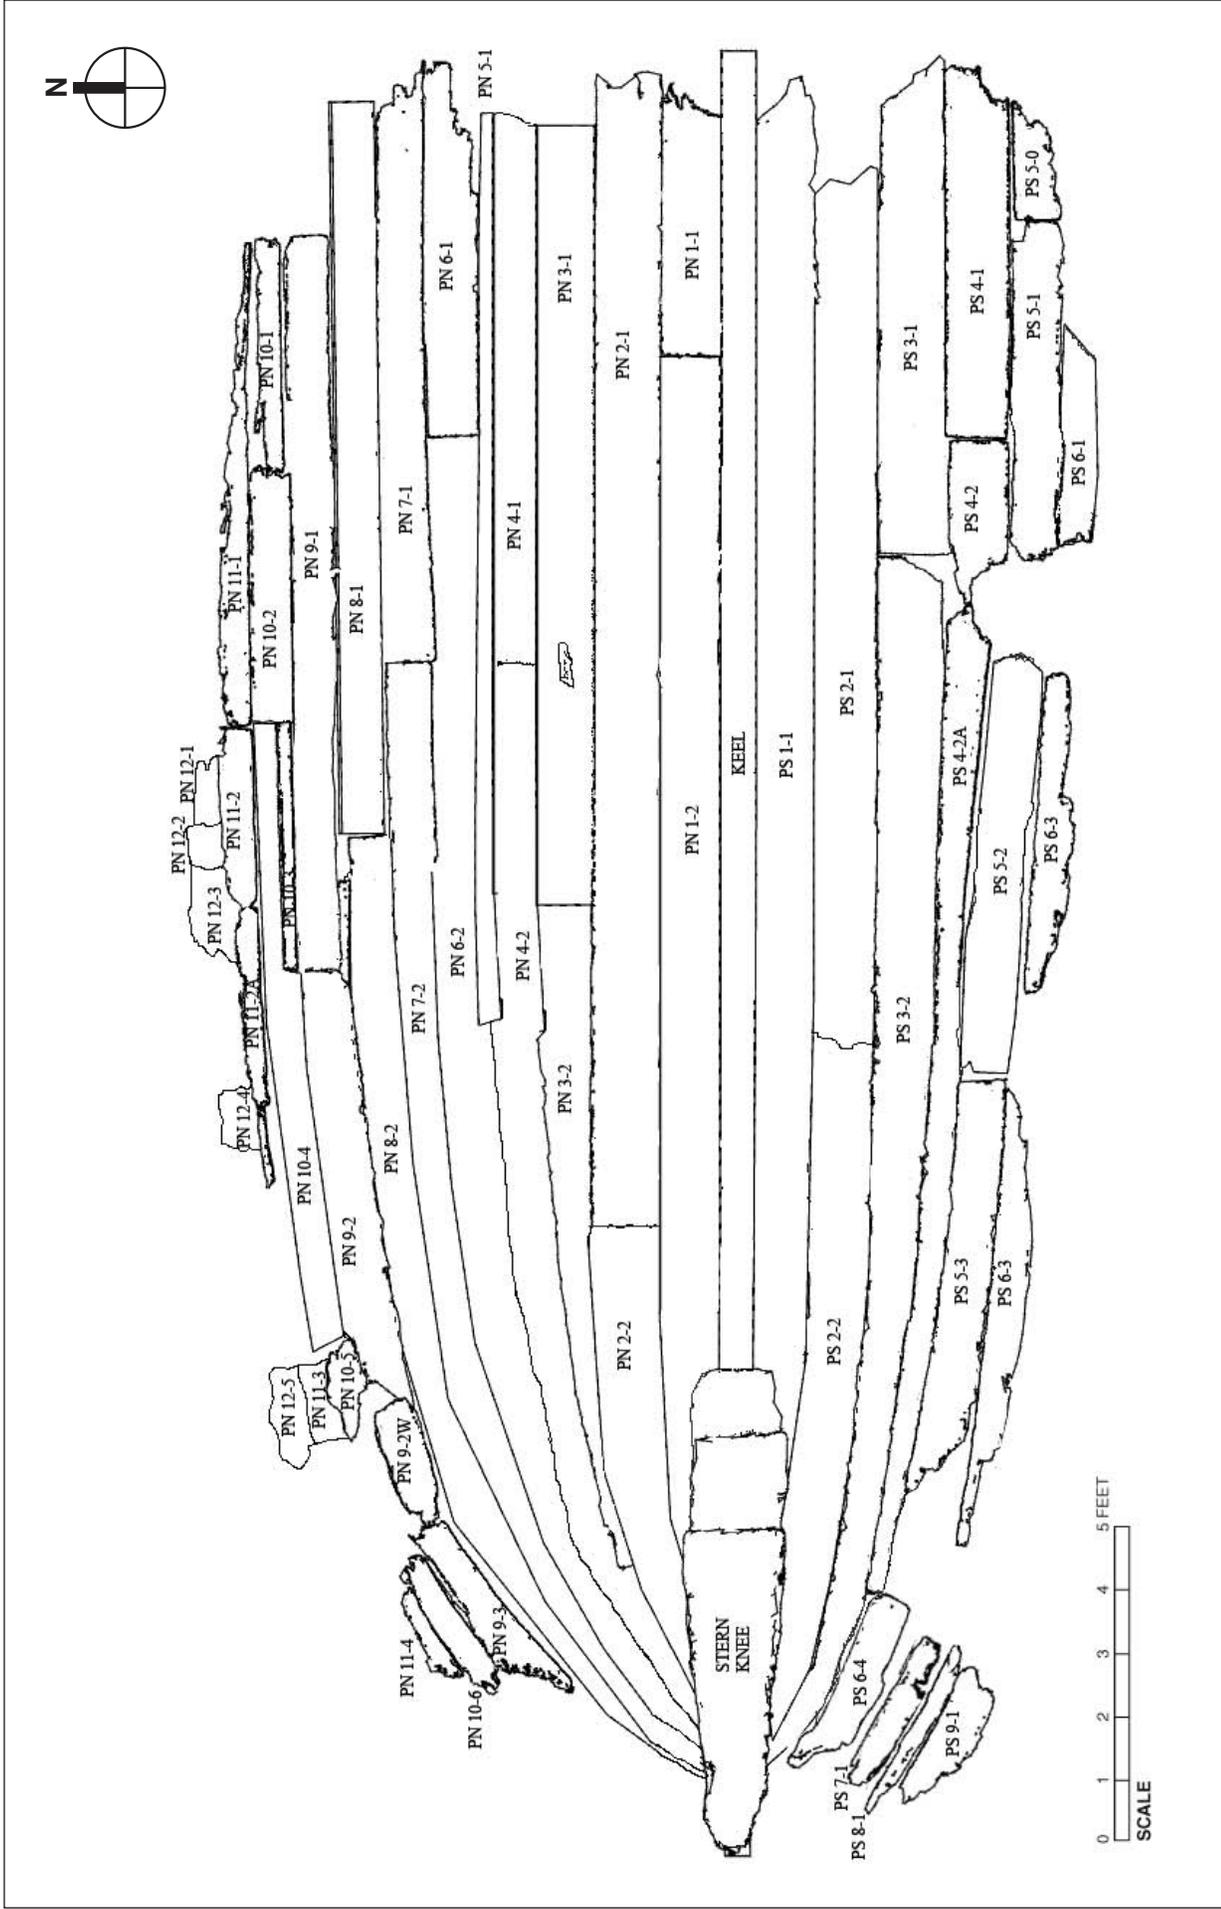
Plan View Drawing of Outer Planking of Stern **Figure 6-13**
