Final Technical Report

**World Trade Center Memorial and Development Plan:
Data Recovery and Analysis of the WTC Ship**

**Blocks 54, Lot 1 and Block 56, Lots 15, 20, and 21
New York, New York**

August 2013

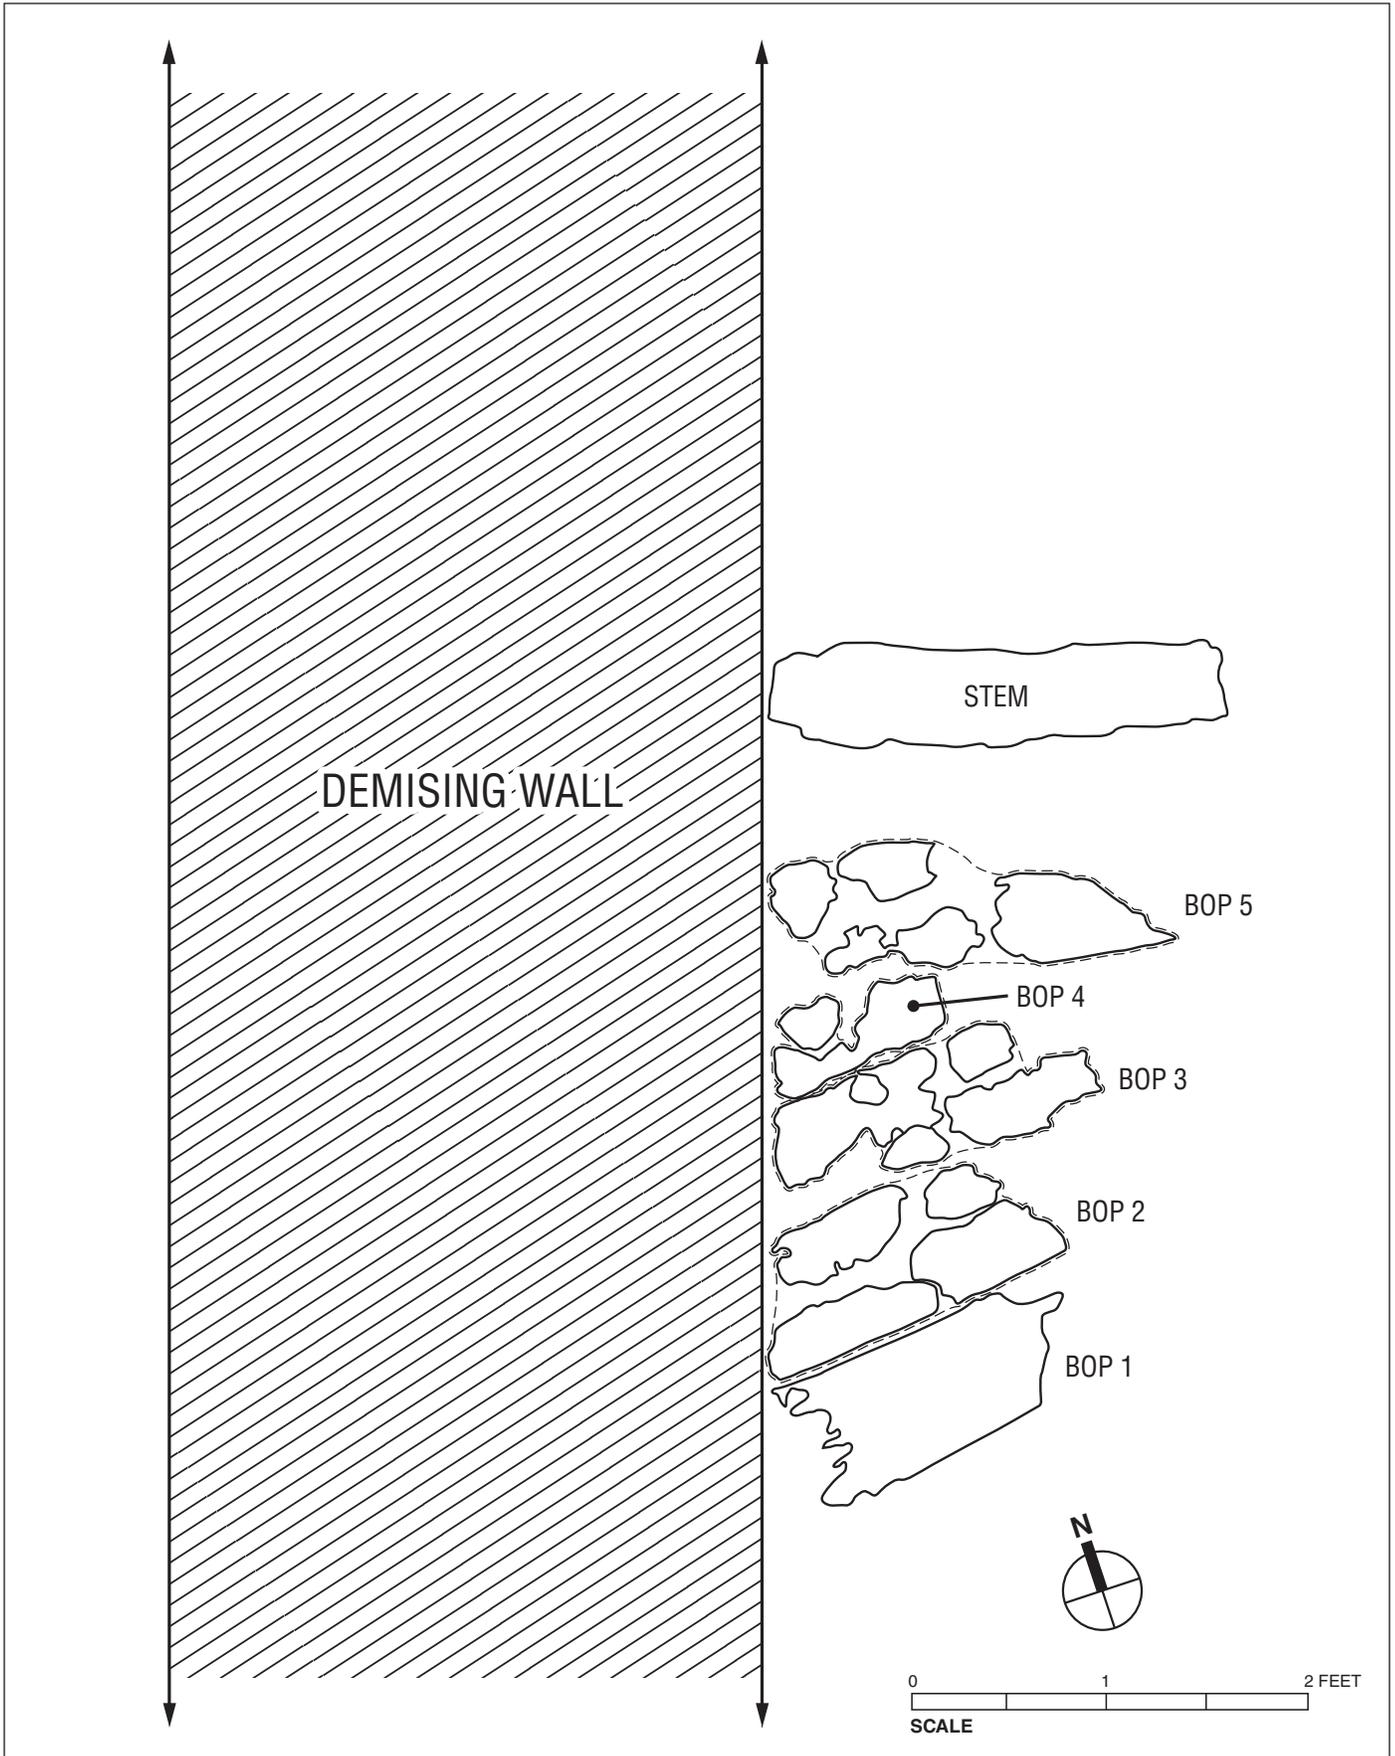
Plan View Drawing
of Outer Planking of Bow
Figure 6-14

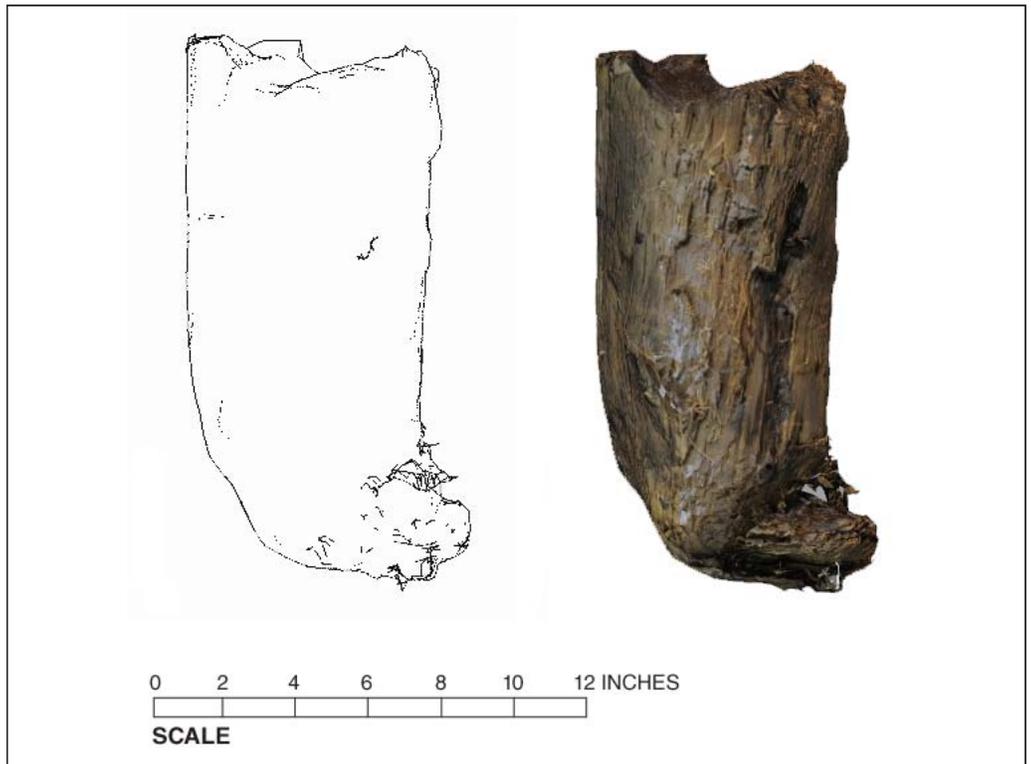
Photograph (right) and rendered view (left) of SN1, made using **A**
PhotoModeler Scanner and Rhinoceros

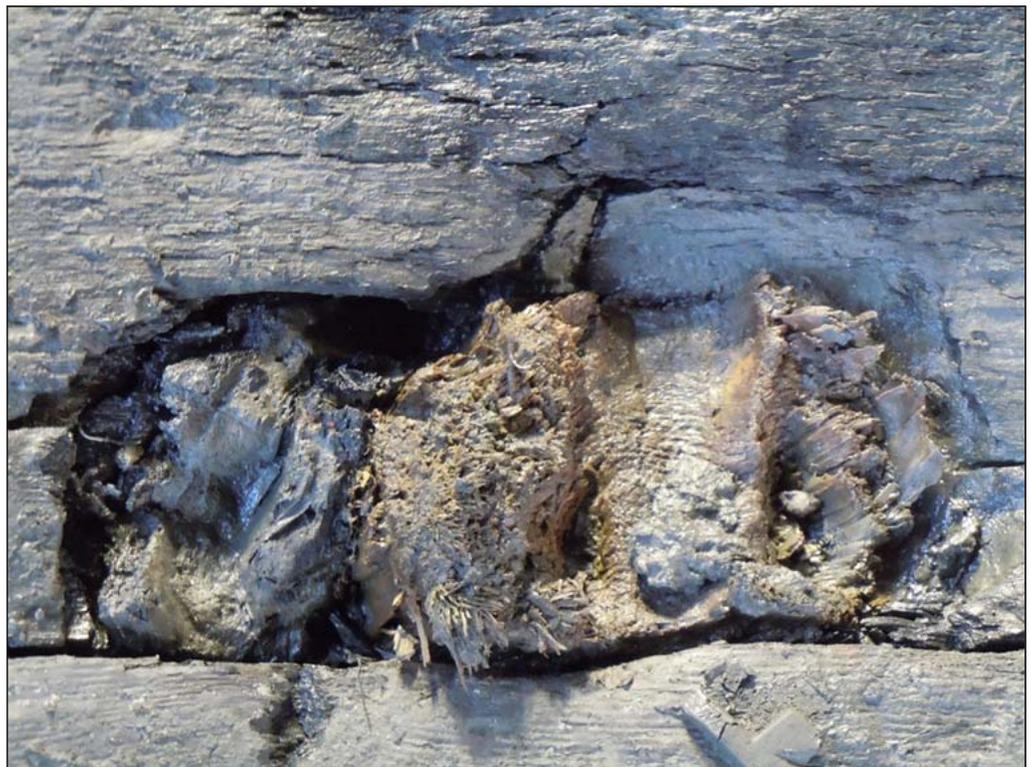
Photograph of top of SN1 *in situ* with ceiling planking. Photograph by Kathleen Galligan **B**

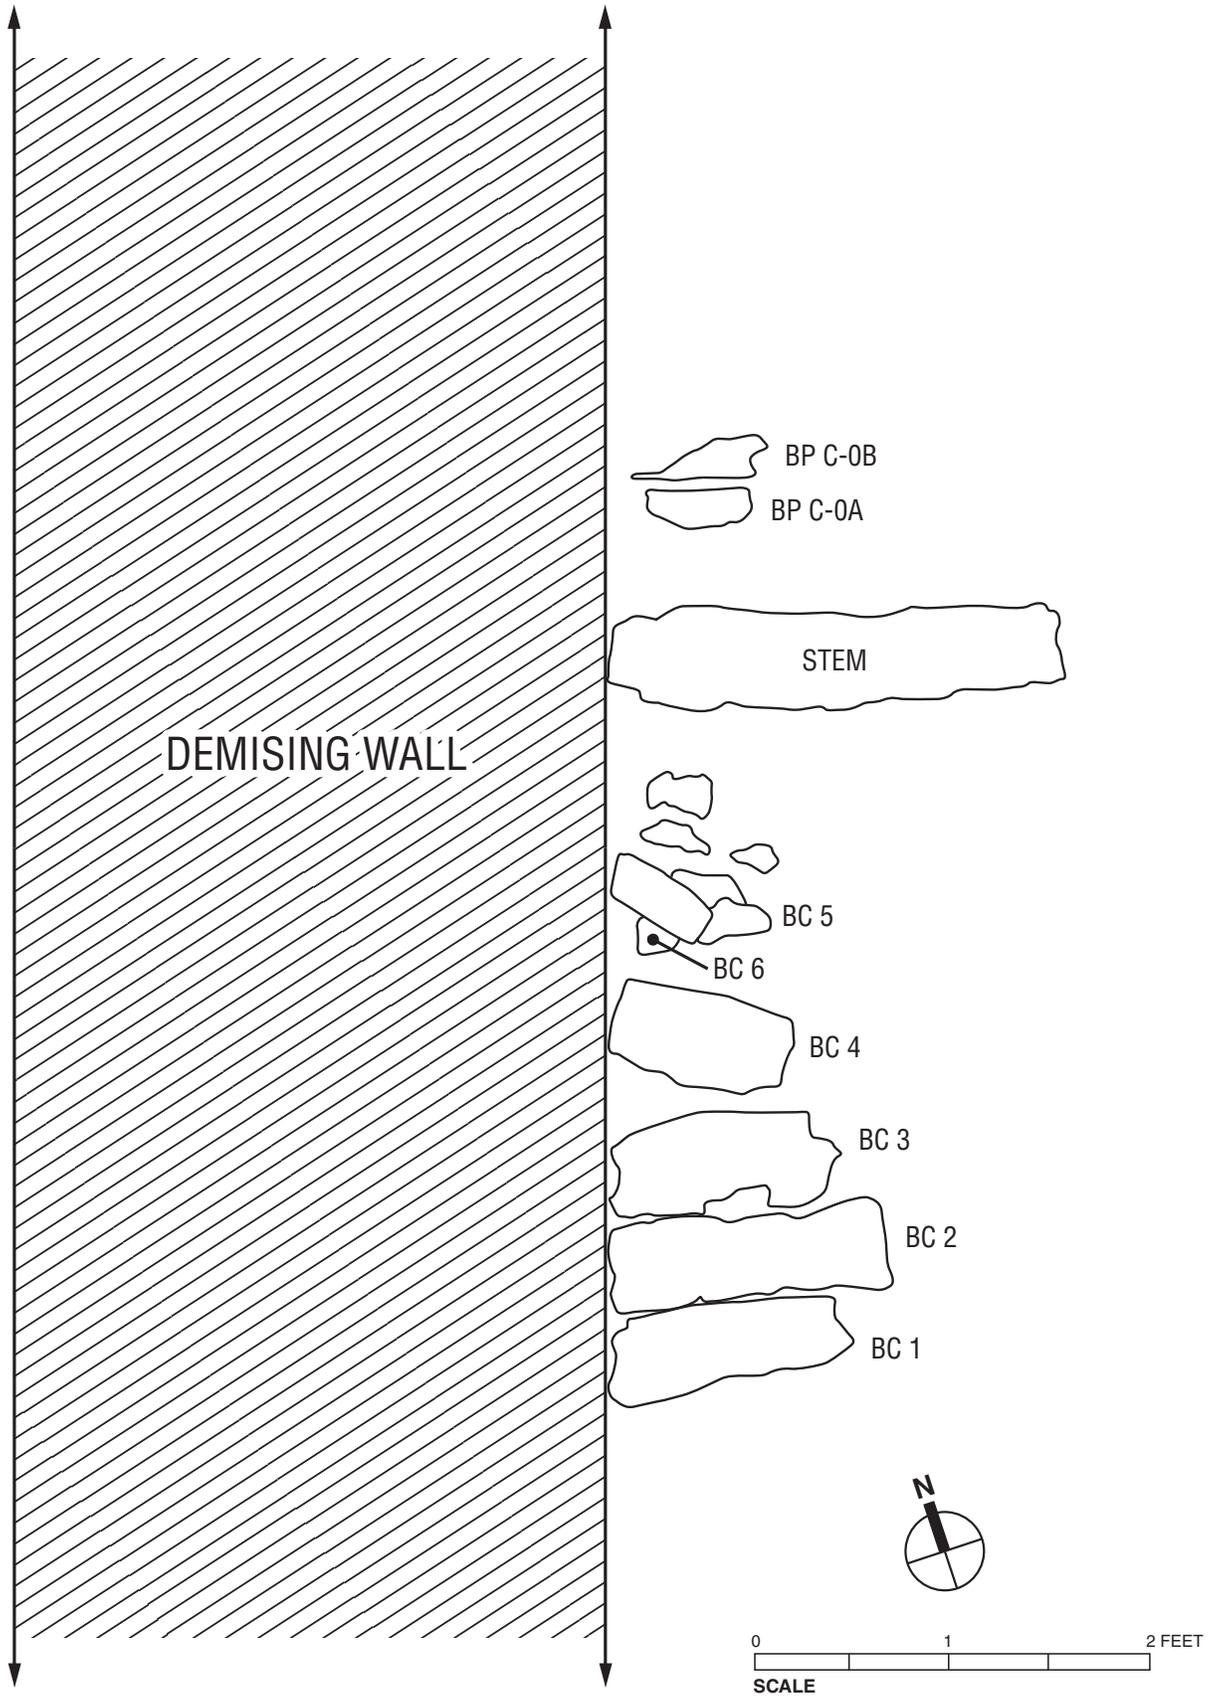
Plan View Drawing
of Ceiling Planking of Bow
Figure 6-16

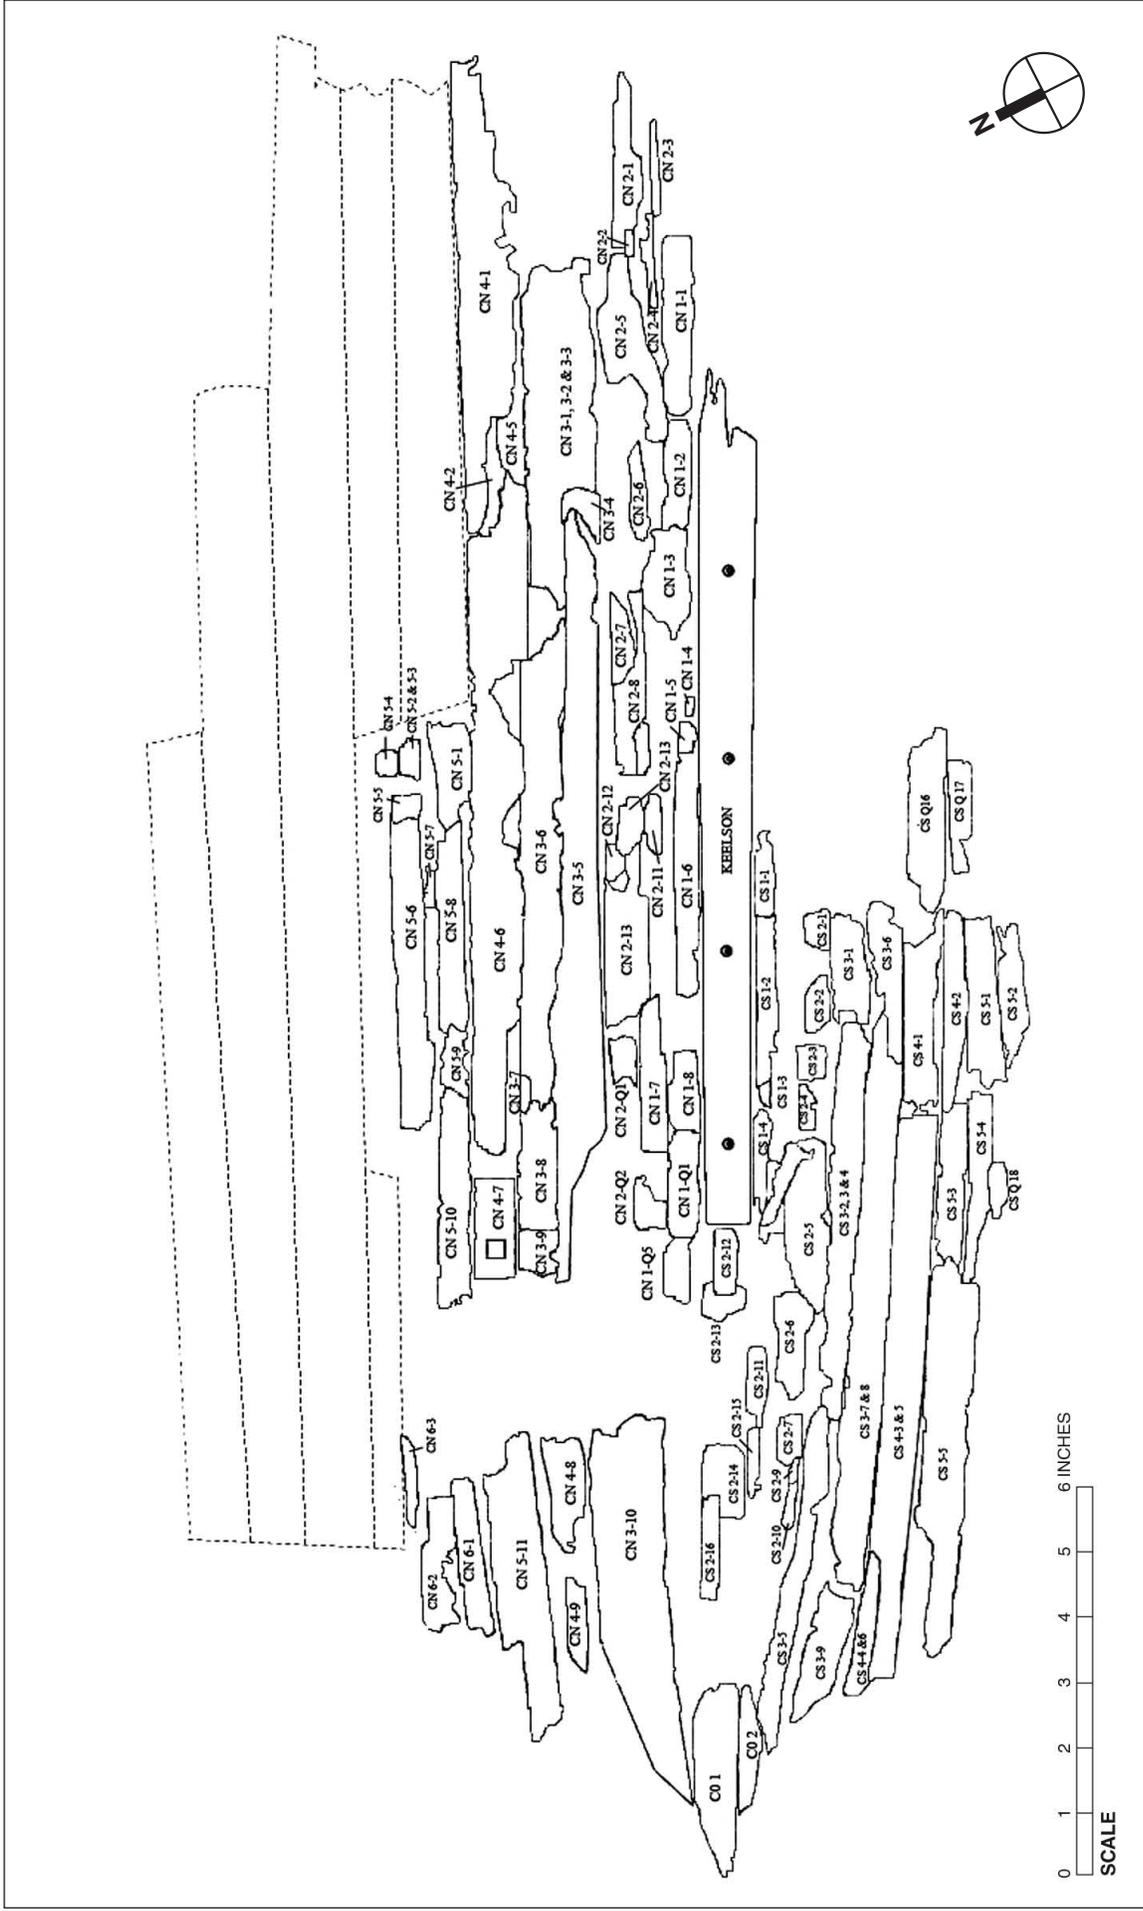
Plan View of Ceiling Planking of Stern
Figure 6-17

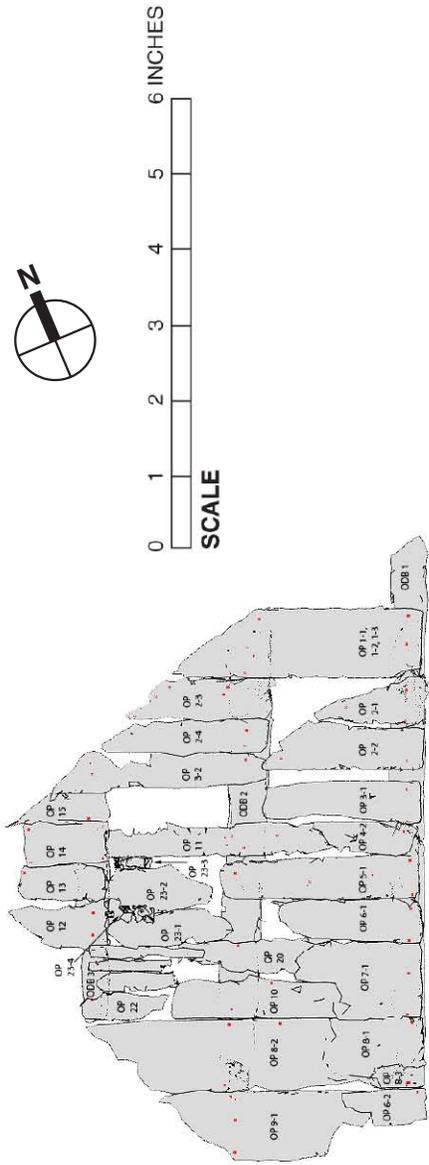
A The construction of deck beams of the orlop deck, viewed from the top. Red nails correspond to the orlop planking

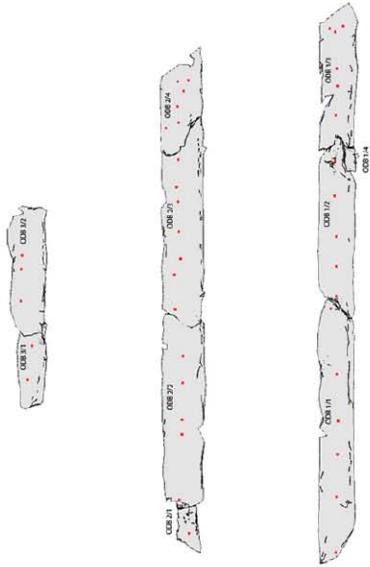
B The construction of planking of the orlop deck, viewed from the top.

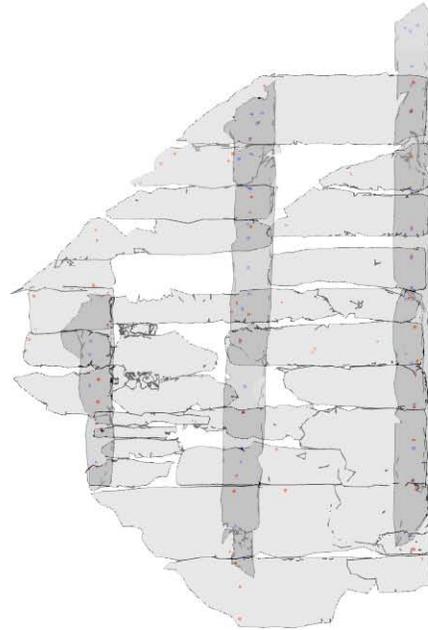
C Overlay of orlop planking over deck beams, viewed from the top. Blue nails correspond to the orlop deck beams.

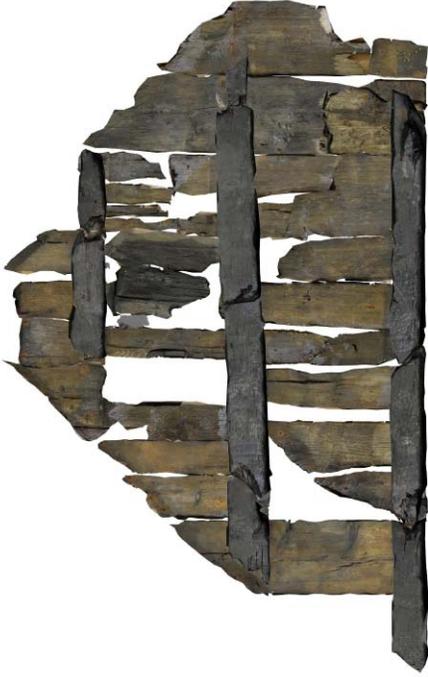
D Rendered view of bottom of the orlop deck

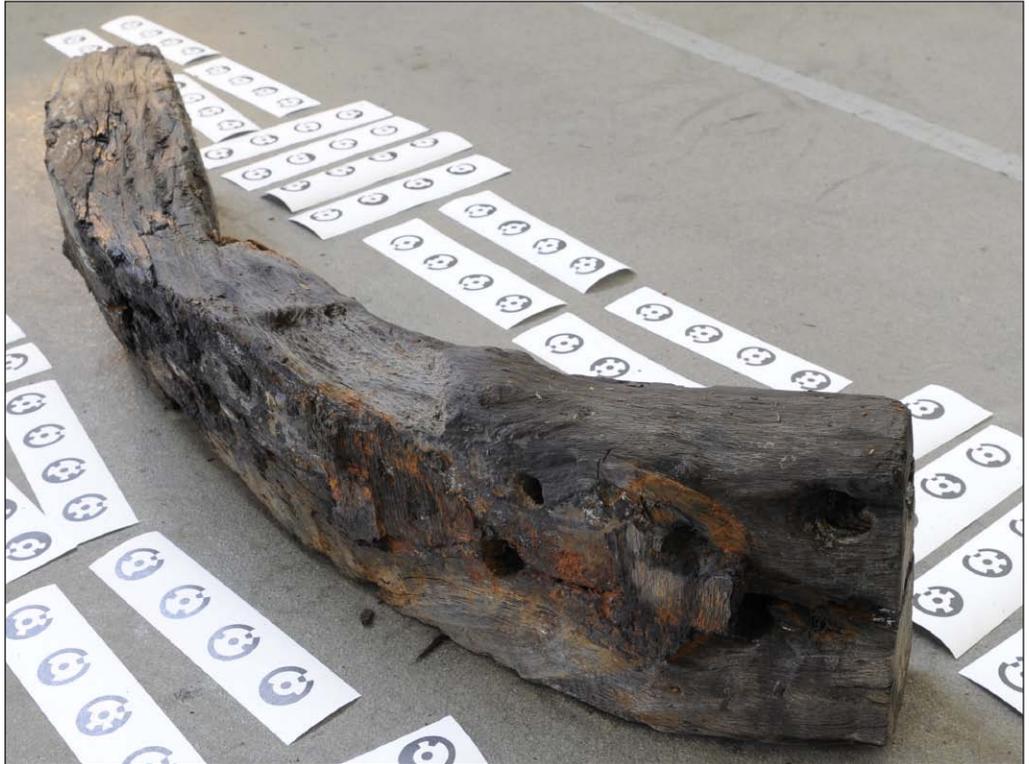
Trunnels to outer planking. Photograph by Drew Fulton **A**

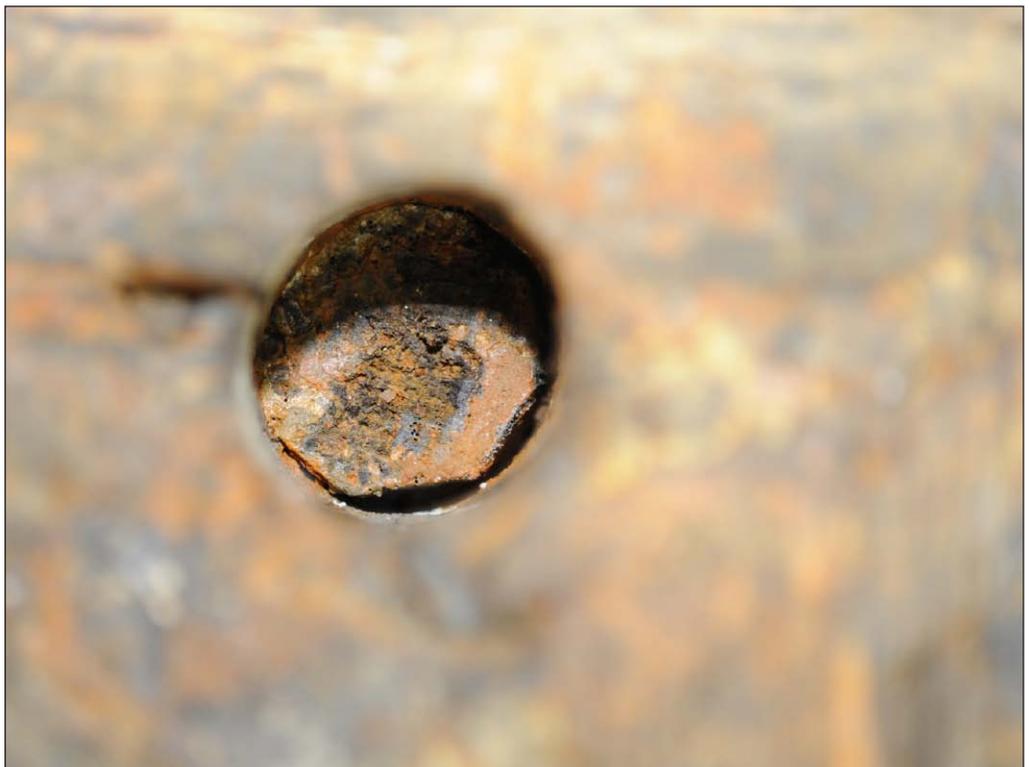
Close-up view of an octagonal trunnel. Photograph by Drew Fulton **B**

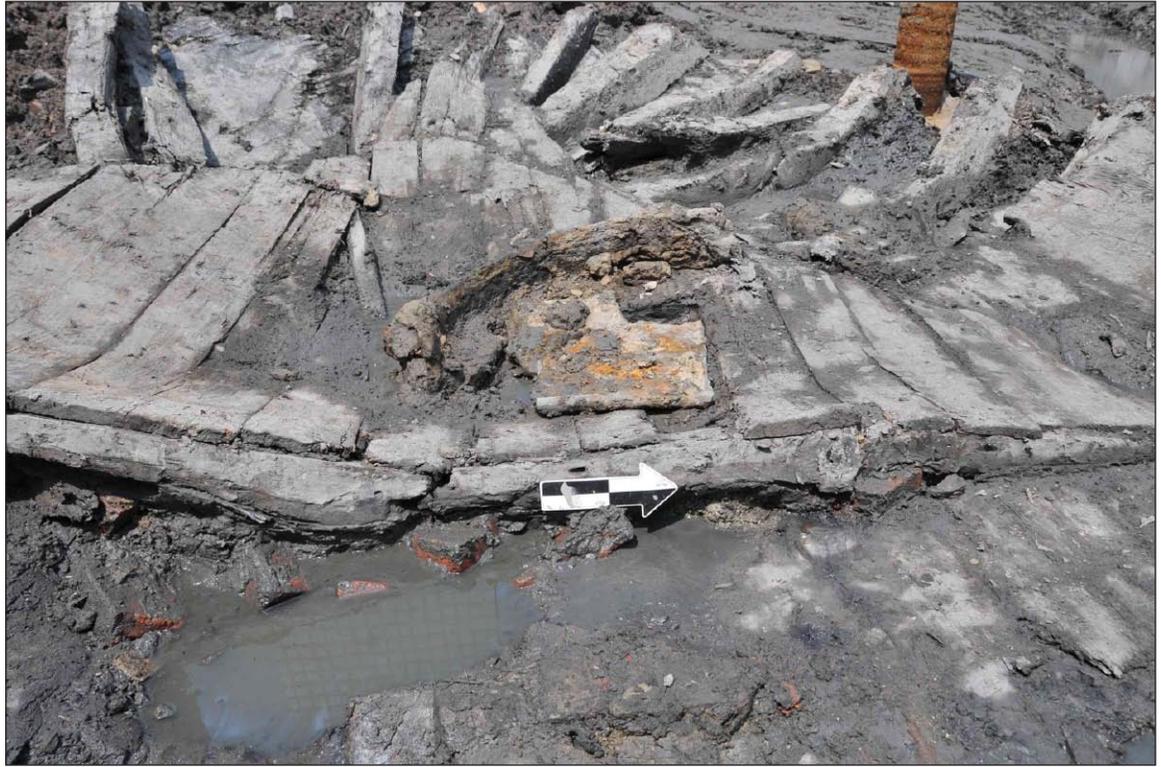
Facing west at stern of Ship Remnant, showing collapsed orlop deck and possible galley hearth **A**

A brick feature, possibly the remains of a galley hearth, was located on the orlop deck of the stern of the ship remnant and was identified and recorded by the field team during excavation. Incorporated into the feature was a semi-circular metal ring that appeared to be fixed to the orlop deck planking with mortar. Brick rubble was also found both on top of and beneath the orlop deck and in limited other locations associated with the ship remnant. Bricks and mortar from these contexts were sampled, placed into plastic bags labeled with provenience information, and transported to the AKRF laboratory where they were washed and catalogued.

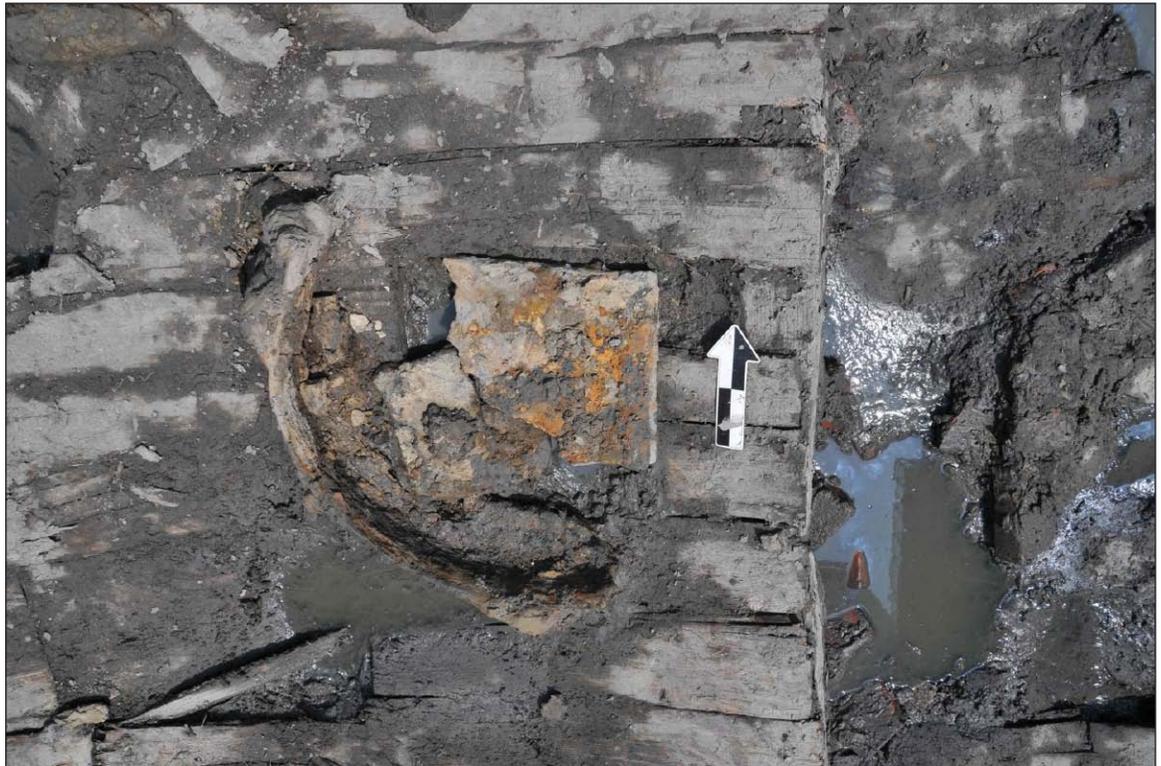
Metal feature in location of possible galley hearth on orlop deck **B**

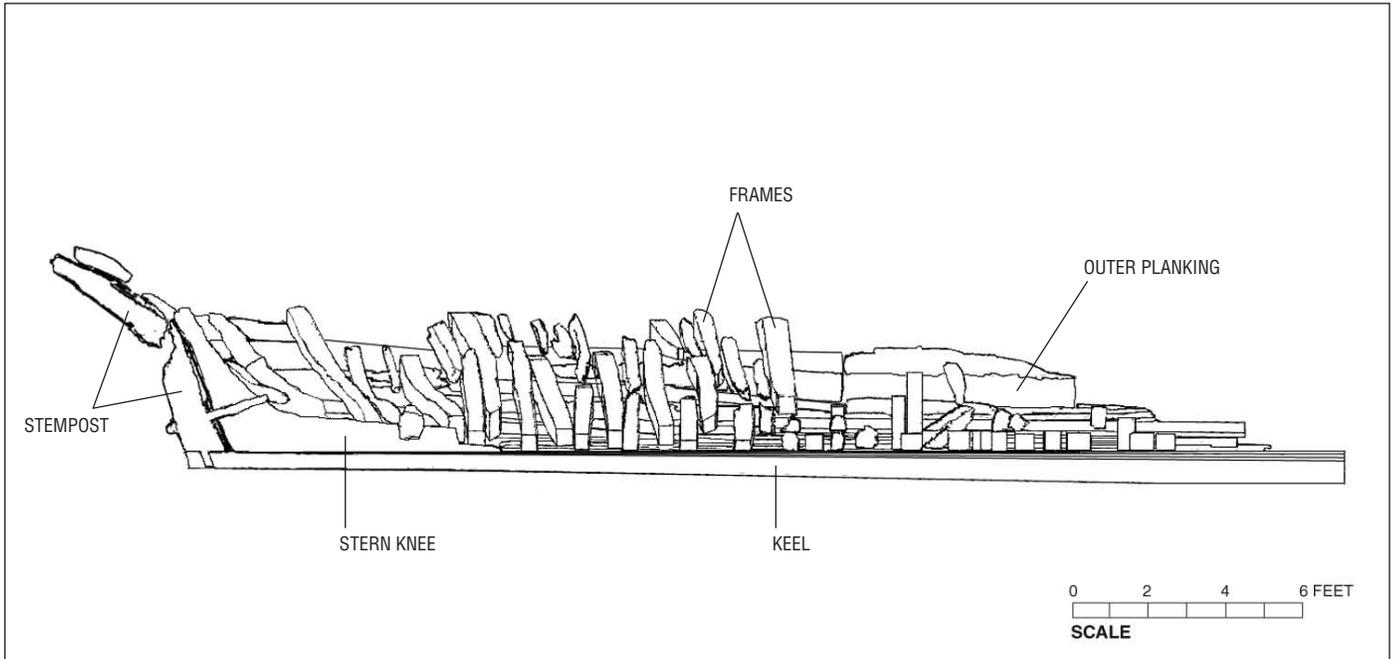
Profile view of starboard side of stern at the keel **A**

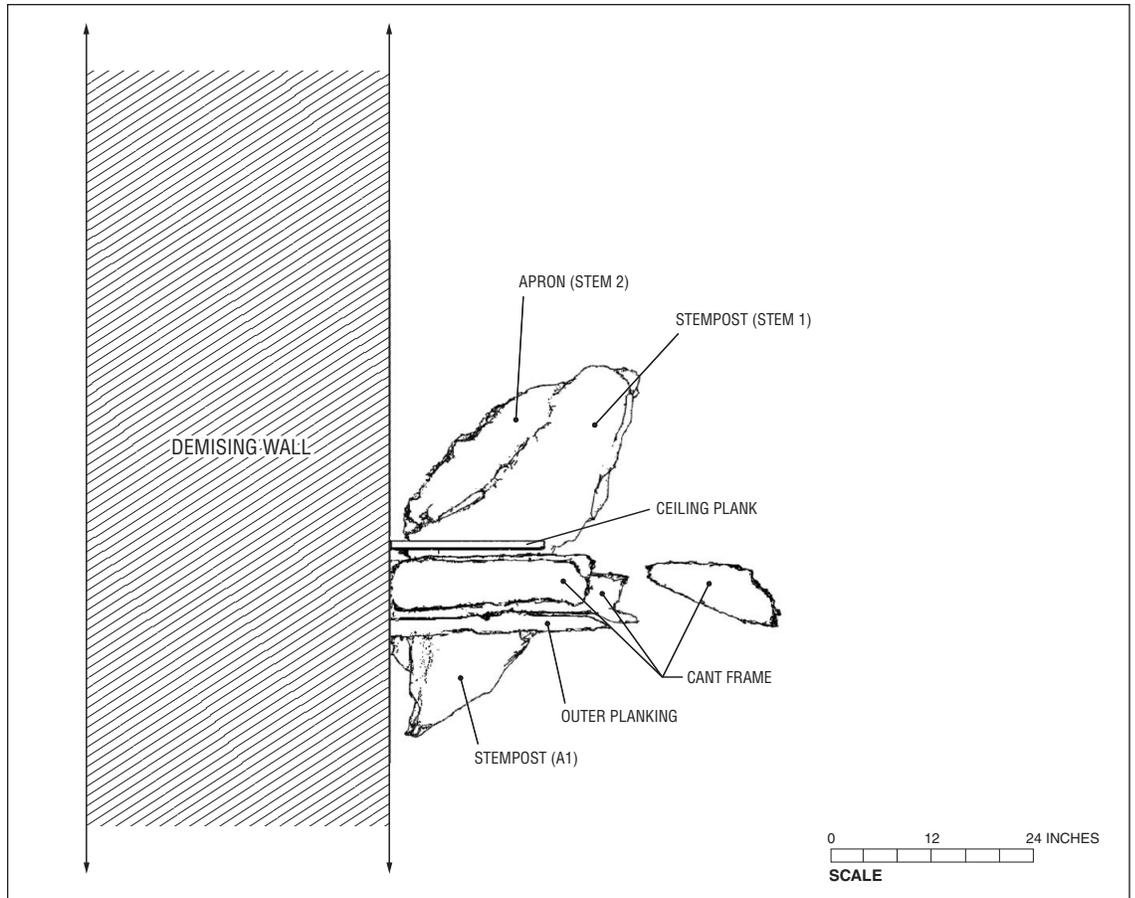
Profile view of starboard side of bow **B**

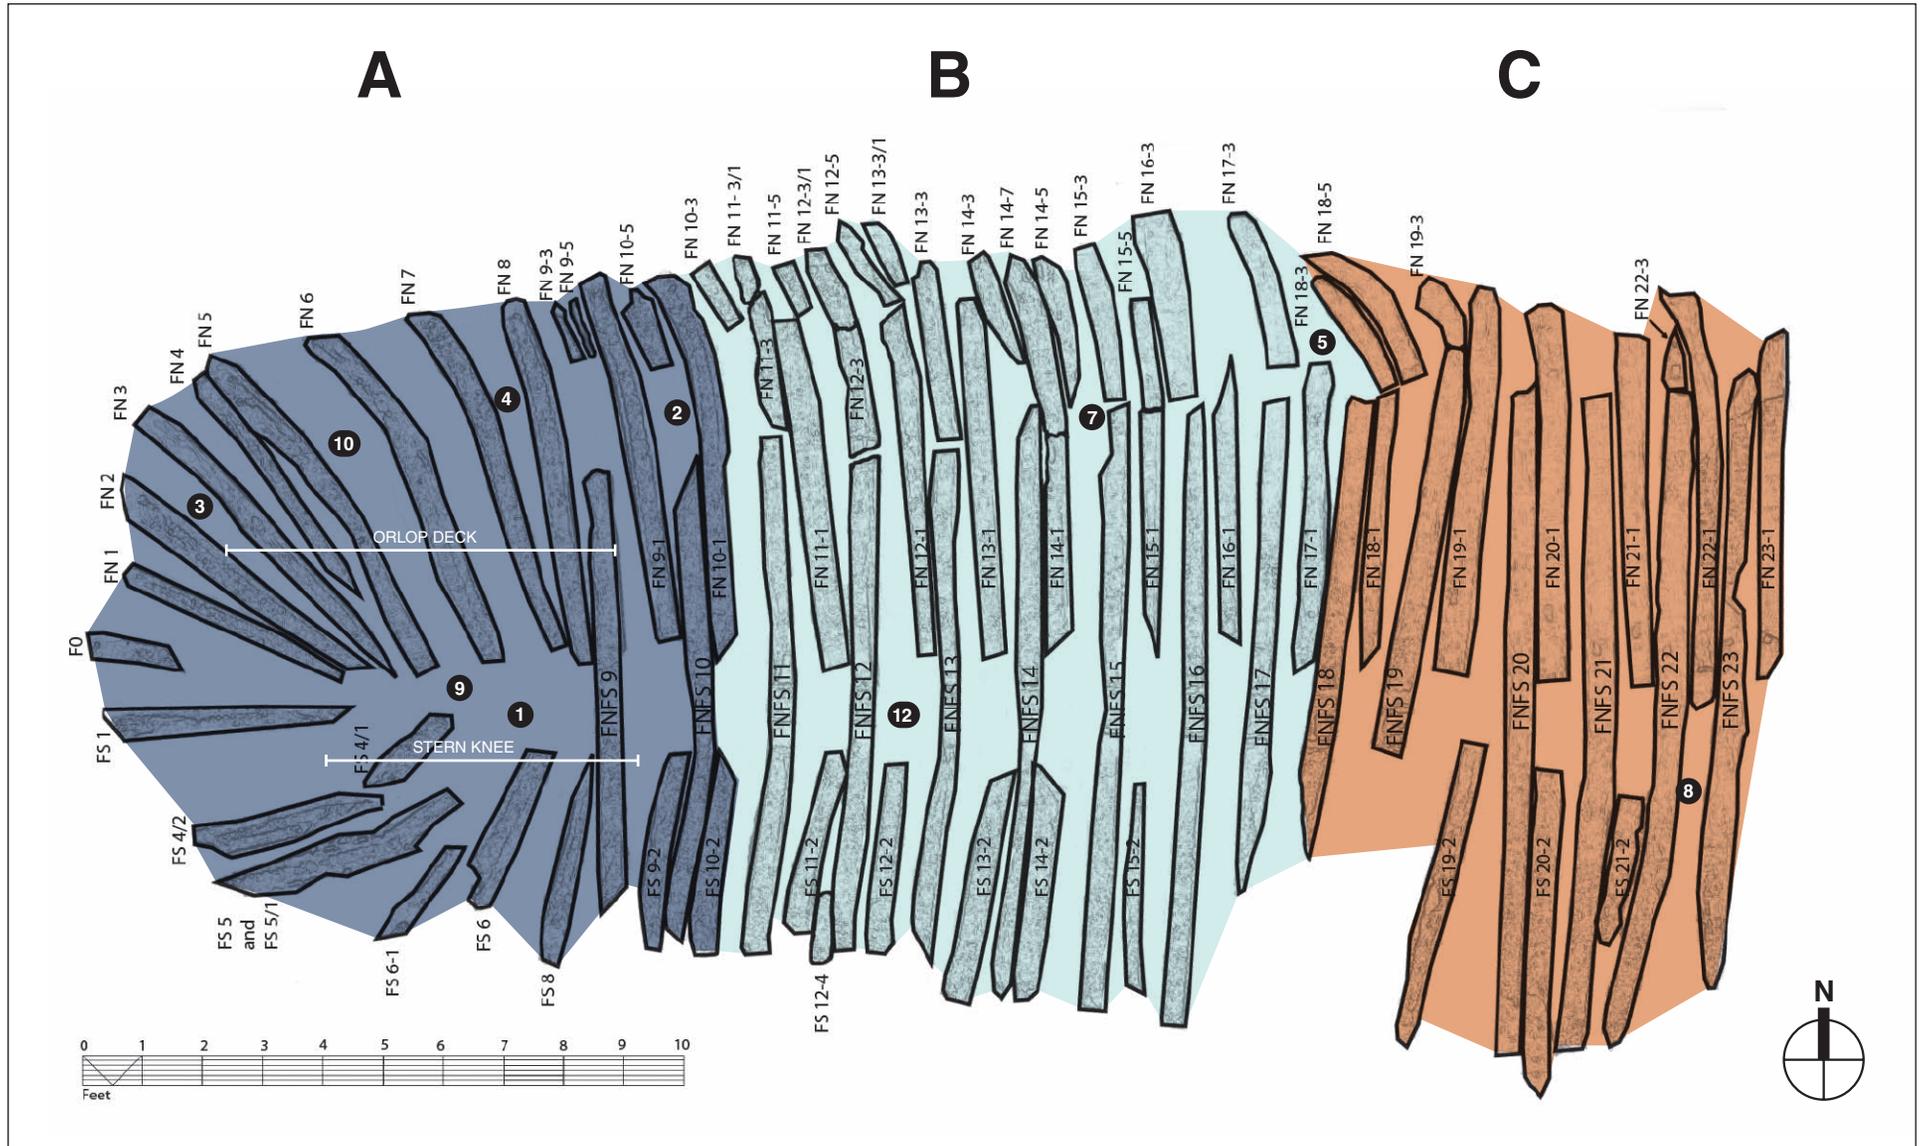
1 Floatation Sample Location and ID number

NOTE: Sample 6 was not within the Ship Remnant; samples 1 and 9 were at different depths within the vessel; and sample 11 was made up of sediments washed into the stern from other parts of the vessel during the archaeological investigation
